INCIDENT INVESTIGATION REPORT

Type of occurrence Exposure to/contact w/ hazardous substance/environment		
Notice of incident number 2017160530032	Incident outcome Fatals (3)	Date of incident October 17, 2017
Location of incident Fernie Memorial Arena 991 6th Avenue Fernie, B.C.	Lead investigator Nigel CORDUFF	Investigation file number FSI-REG-2017-0123
Approved by manager, Fatal and Serious Injury Investigations Jeff YOUNG	Signature 	Date Aug. 22 / 2018

This incident investigation report sets out WorkSafeBC's findings with respect to the cause of and underlying factors leading to the workplace incident that occurred on October 17, 2017, at the Fernie Memorial Arena in Fernie, British Columbia. The purpose of this report is to help employers and workers understand the factors that contributed to the tragic incident so that similar incidents can be prevented in the future.

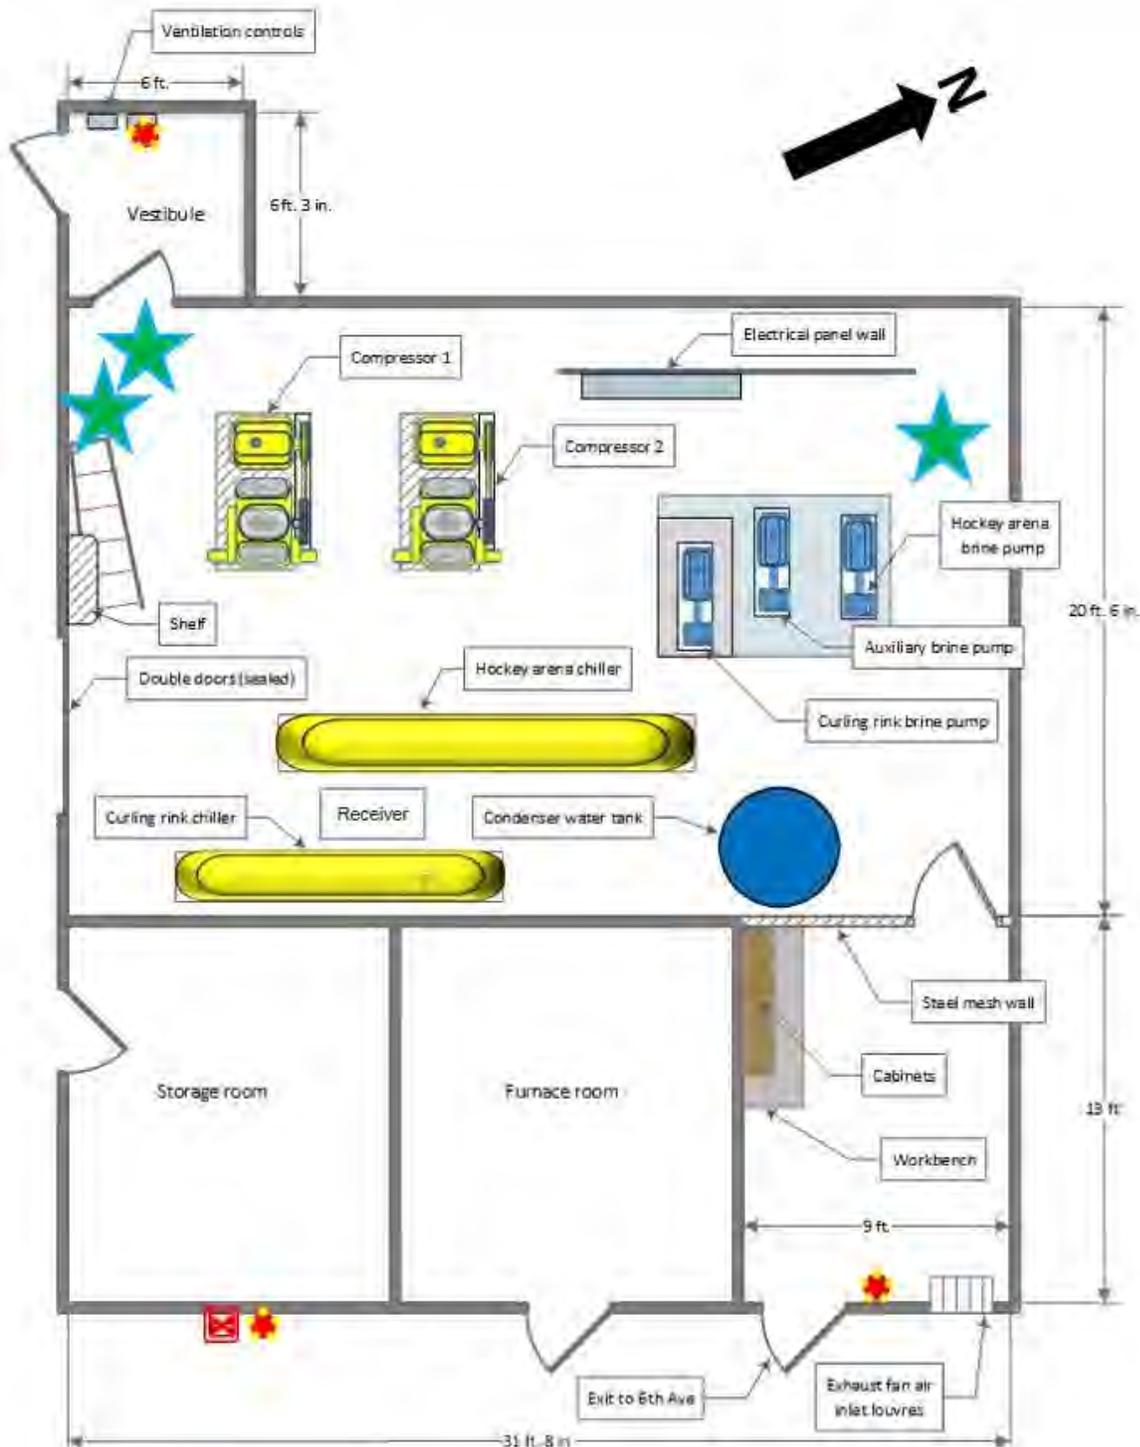
All three of the fatally injured workers were found unresponsive in the main compressor room.

Figure 2: Overhead view of the compressor room. The fatally injured workers (green stars) were located next to the vestibule door and the brine pumps. Emergency stop buttons (red symbols) were located at both exits and next to the emergency ammonia discharge valve (red box) located outside of the compressor room on the storage room wall. Diagram is not to scale.

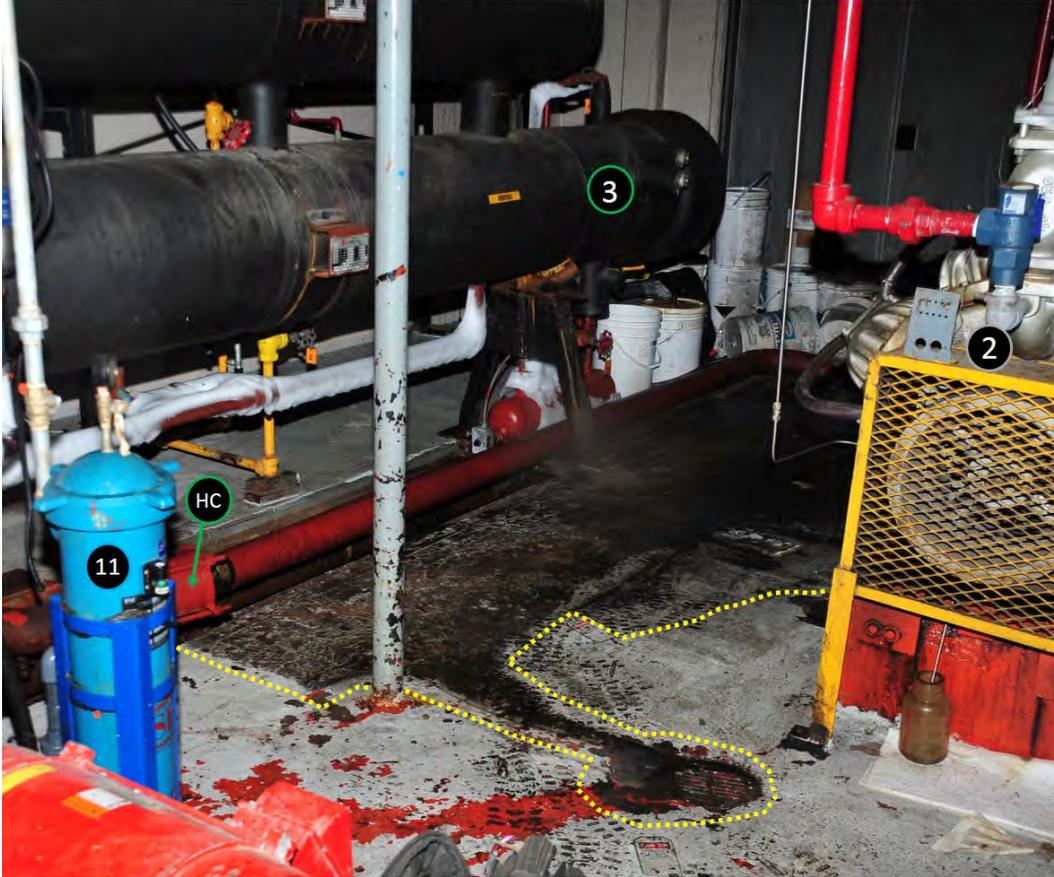
where the curling rink brine outlet pipe had separated. Some of the expelled liquid flowed into floor drains in the compressor room and vestibule. (See Figures 9 and 10.)

Figure 9: The compressor room, looking southeast, showing the brine outlet pipe that separated at HC (horizontal coupling), located under the hockey rink chiller (3). The black, oily liquid that sprayed out of the separated pipe is outlined by the dotted yellow line. Also shown are compressor 2 (2) and the curling rink brine filter (11). (Orange paint is visible through the top coat of grey paint on the concrete floor.) (Source: Ram Environmental Response Ltd.)

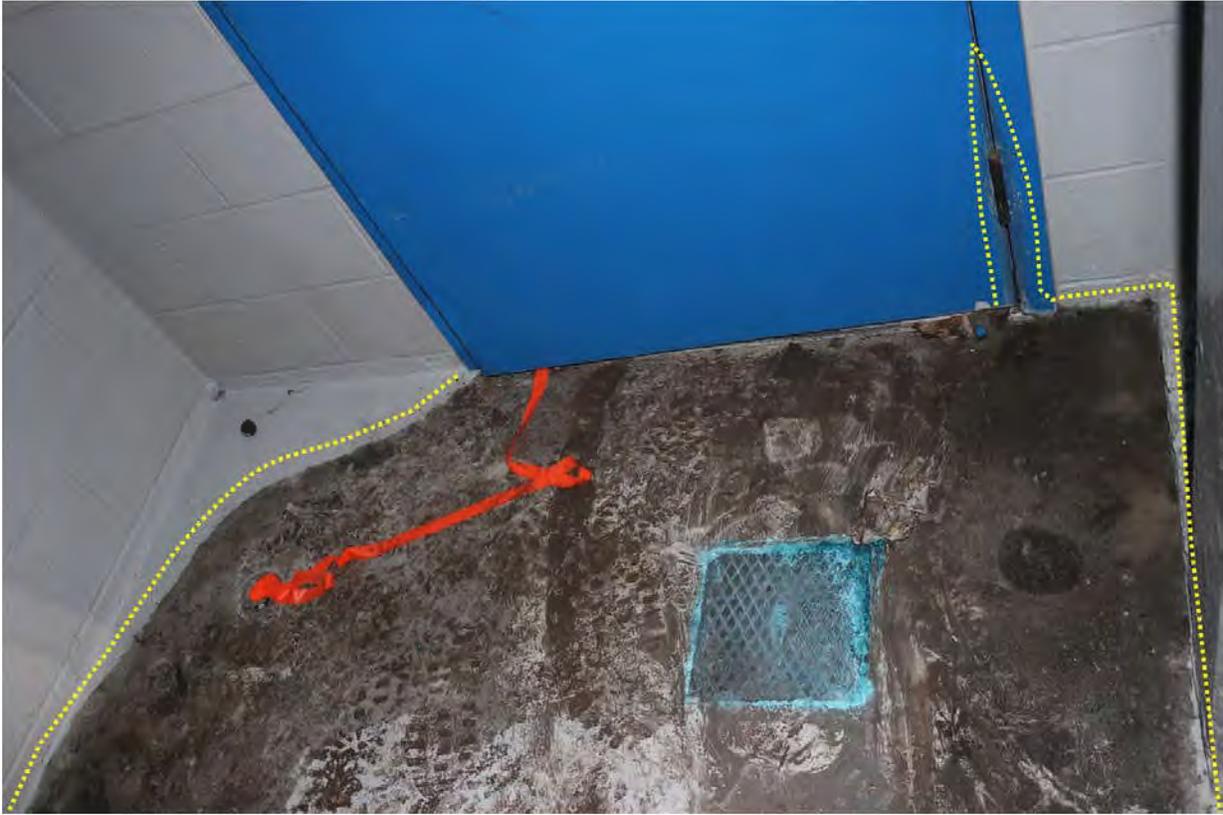
Figure 10: Vestibule floor and door. The oily liquid flowed under the door and through the hinge area. The blue colour on the brass floor plate indicates exposure to ammonia.

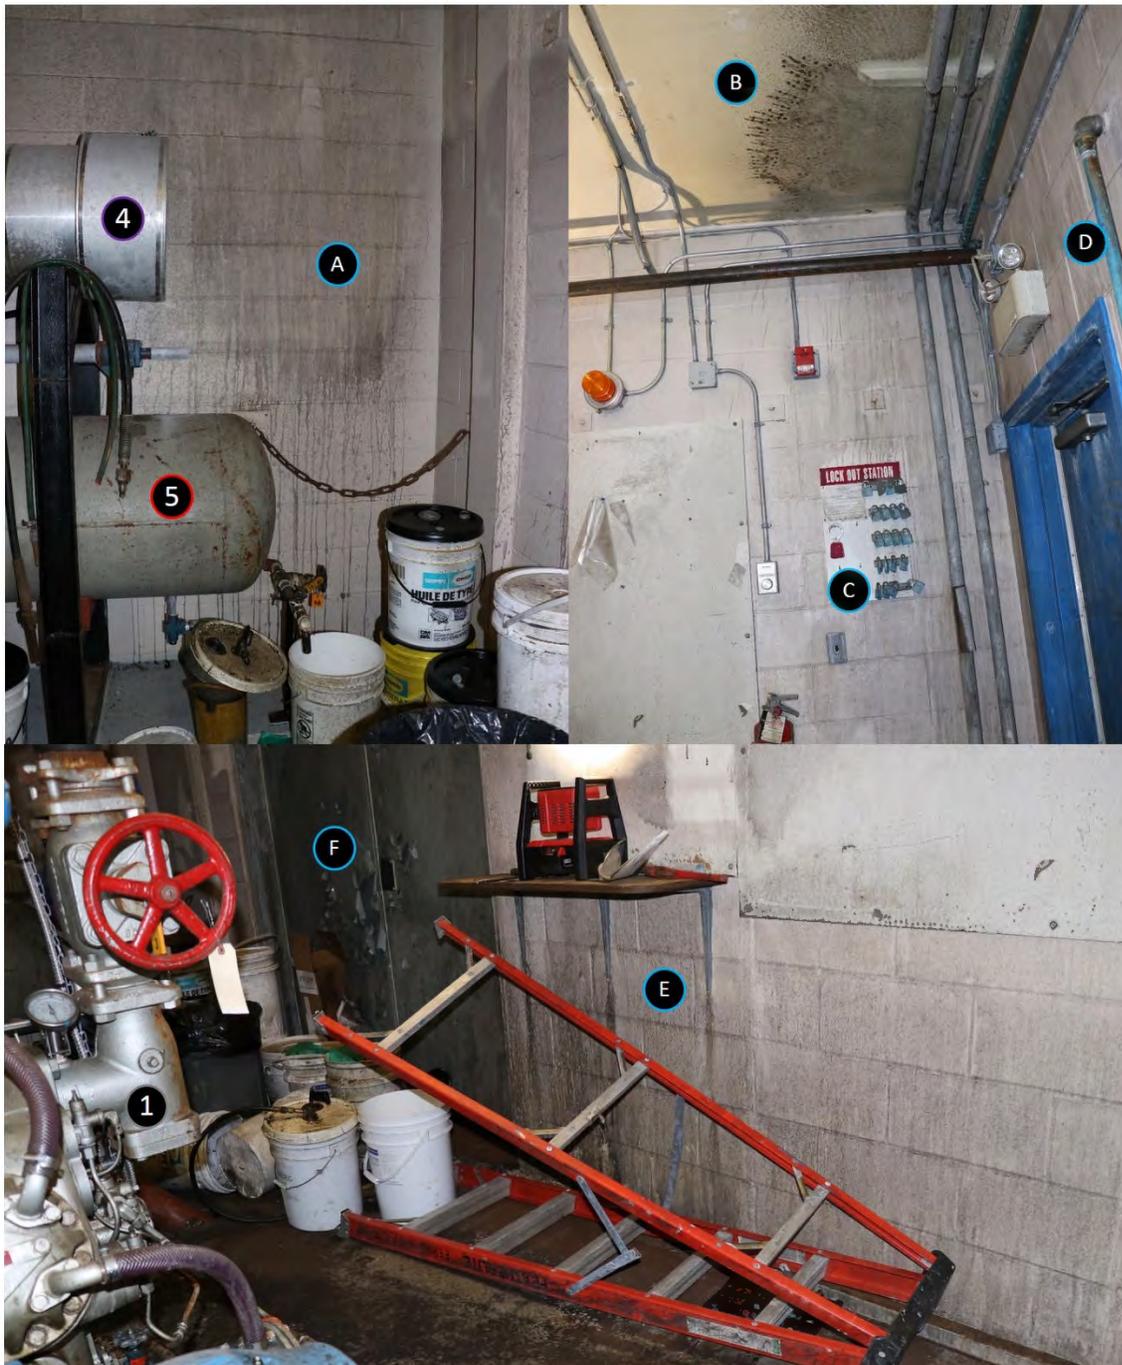
The spray of black, oily liquid in the compressor room was confined to the west side of the room and was observed to be vectored from the separated pipe to the west wall. Spray patterns on the ceiling and walls suggest that there was significant volume and pressure involved when the liquid was deposited on the interior surfaces of the compressor room. (See Figure 11.)

Figure 11: Composite images of the compressor room, showing spray patterns from the separated pipe: Spray on the south wall (A) behind the end of the curling rink chiller (4) and receiver (5) and on the ceiling above the vestibule door at the north corner (B). The brass locks (C) and copper pipe (D) turned blue due to ammonia exposure. Behind compressor 1 (1) is spray and pooling of black liquid on the west wall and floor (E). The paint peeled off the sealed double door (F) after exposure to the ammonia-brine mixture.

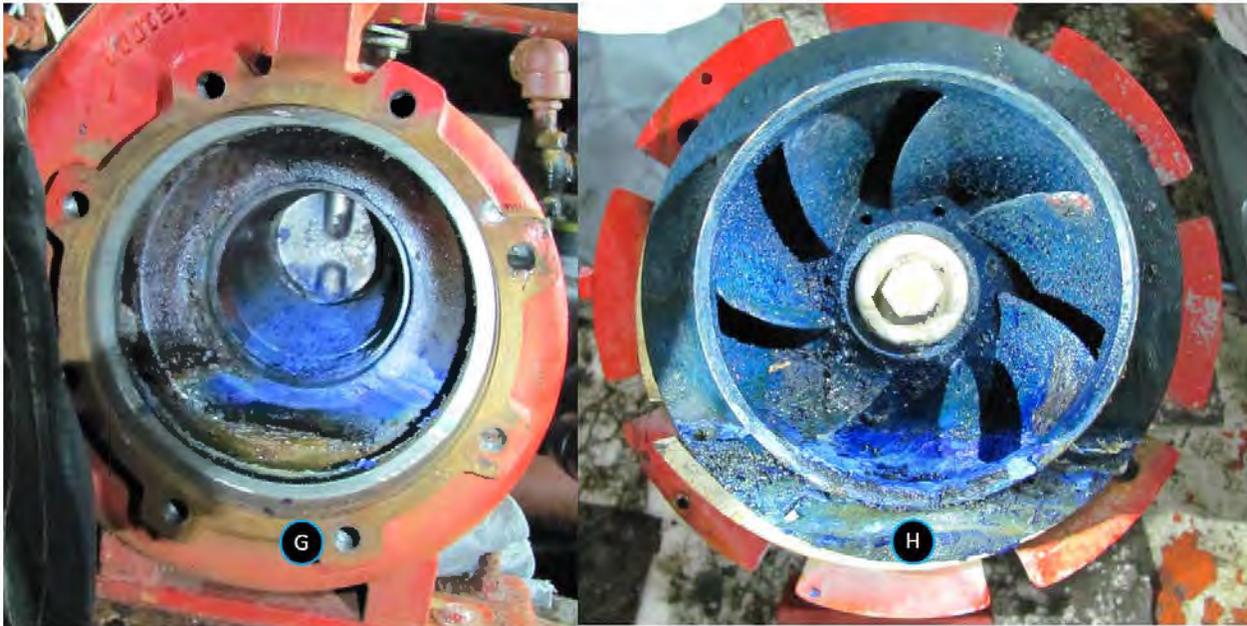
All three of the brine circulation pumps were leak-checked, disassembled, and examined at the incident site. No foreign material, broken machine parts, or other obstruction was observed that would prevent any of the brine pumps from operating as intended. It was observed that the curling rink brine loop piping materials that contained copper or zinc alloys had reacted unfavourably from exposure with the ammonia-brine mixture, causing noticeable corrosion or discoloration. This effect was quite pronounced on the copper alloy/bronze impeller for the curling rink brine pump but was not observed on the other two brine pumps, which were isolated from the curling rink chiller. (See Figure 12.)

Figure 12: The interior of the curling rink brine pump housing (G) and the pump impeller (H), showing the corrosive effect of ammonia to some metals in the system, in this case the copper alloy/bronze pump impeller.

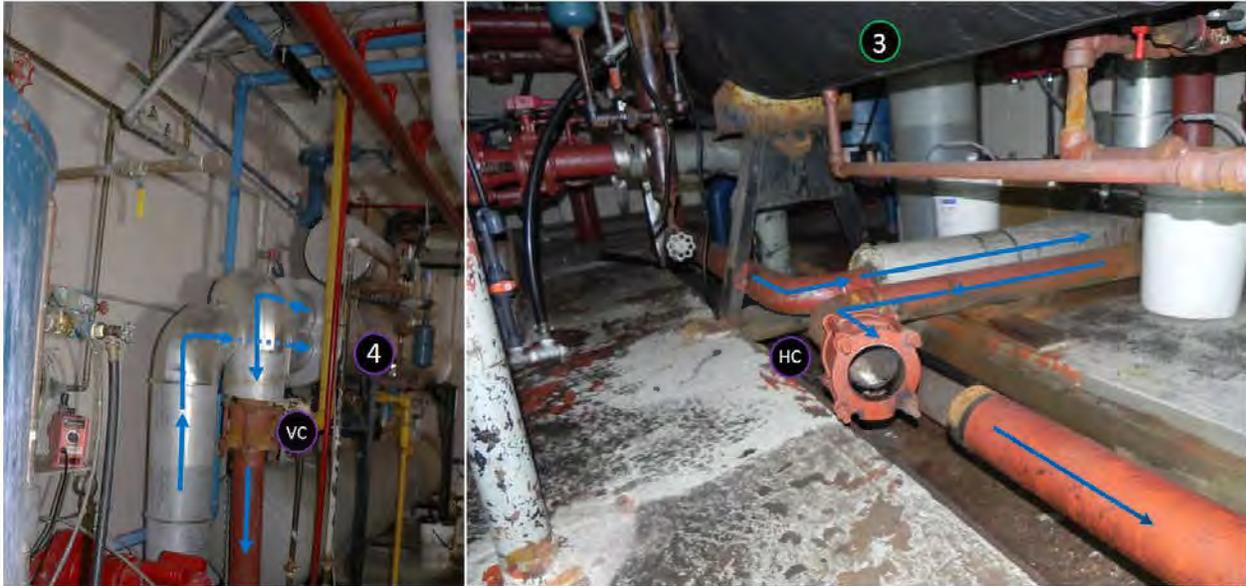
All of the brine piping was comprised predominately of schedule 40 steel pipes at diameters between 4 and 6 inches. All of the flanges and joints were welded or bolted connections with the exception of the 4-inch-diameter curling rink brine outlet pipe. At this location, two connections were made using bolted, sleeve-type couplings. One connection was mounted in a vertical position (VC in this report), and the other was mounted horizontally (HC in this report). The pipe that separated at the time of the incident did so at the HC joint. (See Figure 13.)

Figure 13: The photograph on the left shows the position of the vertical coupling (VC) on the brine outlet pipe of the curling rink chiller (4). The photograph on the right shows the horizontal coupling (HC) under the hockey rink chiller (3) and downstream of the VC. The normal brine circulation path is indicated by the blue arrows.

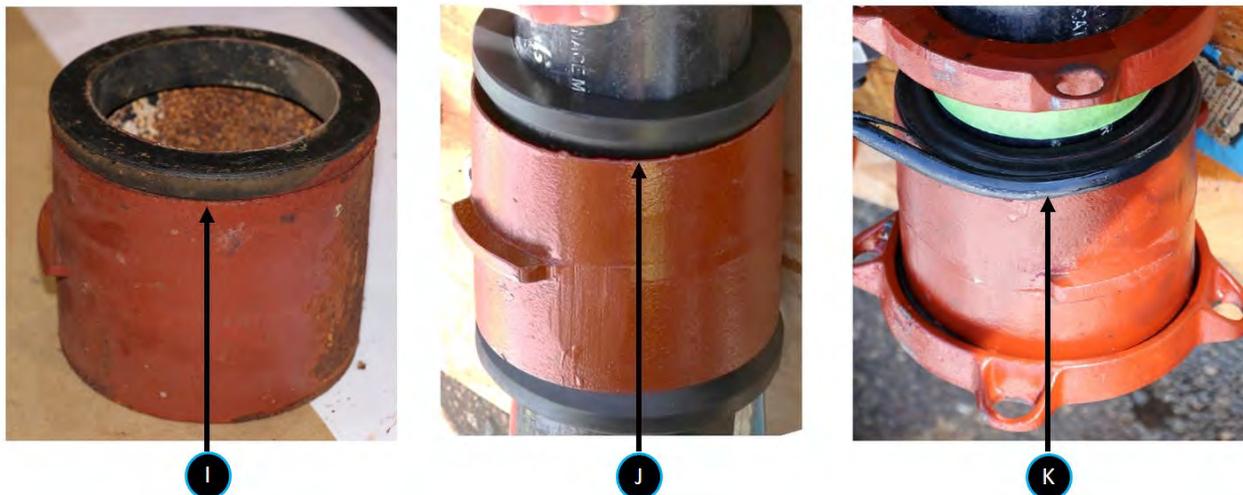
The VC and HC from the compressor room were also disassembled. WorkSafeBC investigators observed that the gasket face from the HC assembly removed from the compressor room did not have the same identifiable pattern impression and more closely resembled the new, uninstalled gasket from the pipe coupling exemplar. (See Figure 14.)

Figure 14: The HC gasket face as found in the compressor room (I); the new, uninstalled gasket face at the same location on the pipe coupling exemplar (J); and the new gasket less than one hour after being installed as per the manufacturer’s instructions (K).

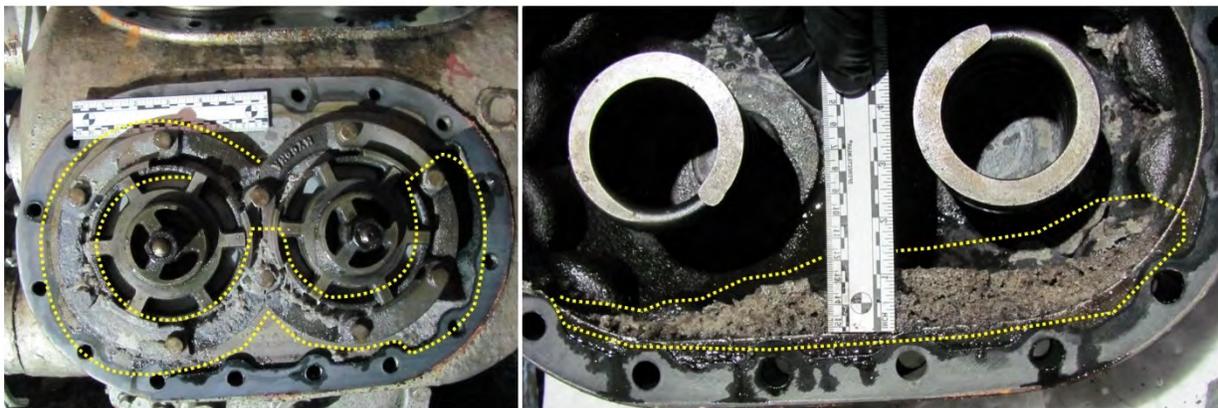
Each compressor has eight cylinders, located in four banks of two. When the cylinder head covers were removed, substantial crystal growth could be observed in both compressors. (See Figure 15.) The crystalline growth was indicative of brine infiltration into the compressor cylinders, which is an abnormal operating condition. The ammonia gas compressors are not designed to handle any liquid. There was no mechanical connection of the ammonia gas compressors to the brine system. As such, inadvertent misdirection of brine into the ammonia gas compressors should not be possible.

Figure 15: Crystal accumulation (yellow outline) in the ammonia gas compressor cylinder heads, showing cylinder heads on the left and a cylinder head cover and springs on the right.

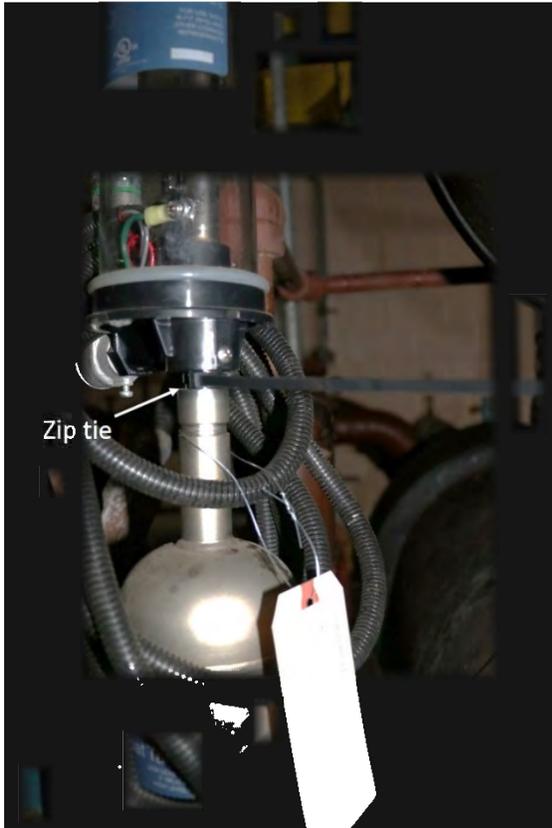
Laboratory results determined that the hockey rink liquid level control was functional, but the ammonia liquid high-level shutdown switch had been defeated by a plastic zip tie and therefore was not functional at the time of the incident. This meant that the entire ammonia pressure shell for the hockey rink chiller could have been filled with ammonia liquid when the chiller was in operation. (See Figure 16.)

Figure 16: Photograph showing a black plastic zip tie used to defeat the factory setting on the ammonia liquid high-level shutdown switch on the hockey rink chiller.

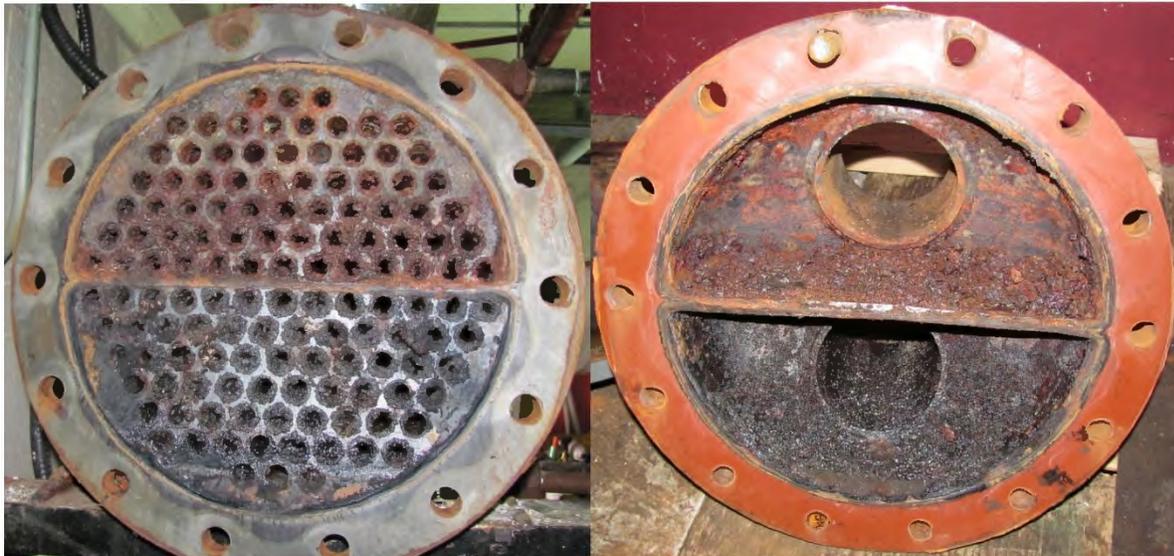
Examination of the tube sheet ends showed a substantial buildup of black, oily liquid. (See Figures 19 and 20.) This residue was determined to be the same as the liquid that had been found sprayed around the west end of the compressor room, where the brine outlet pipe had separated. The accumulation of black liquid was more pronounced in the lower hemisphere of the curling rink chiller than the top hemisphere. In some cases, the brine tubes appeared to be completely blocked, which may have reduced the efficiency of the heat exchange process in the chiller when it was in operation.

Figure 19: The photograph on the left shows the inlet/outlet end of the tube sheet of the curling rink chiller. The photograph on the right shows the dome cover with gasket in place as intended.

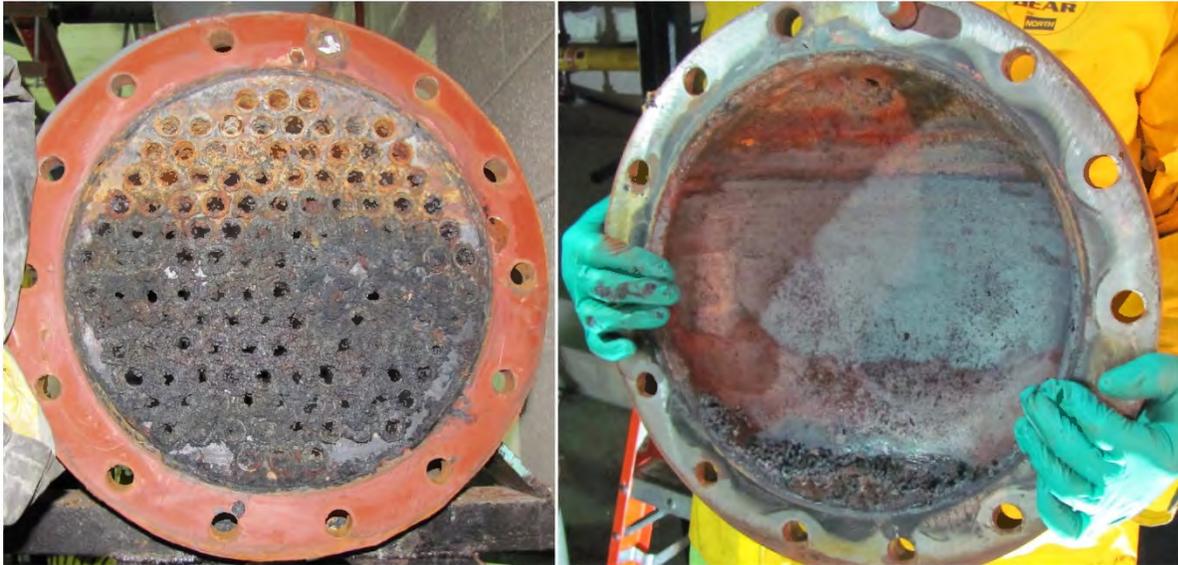
Figure 20: The photograph on the left shows the return end of the tube sheet of the curling rink chiller with the gaskets intact. The photograph on the right shows the return end dome cover.

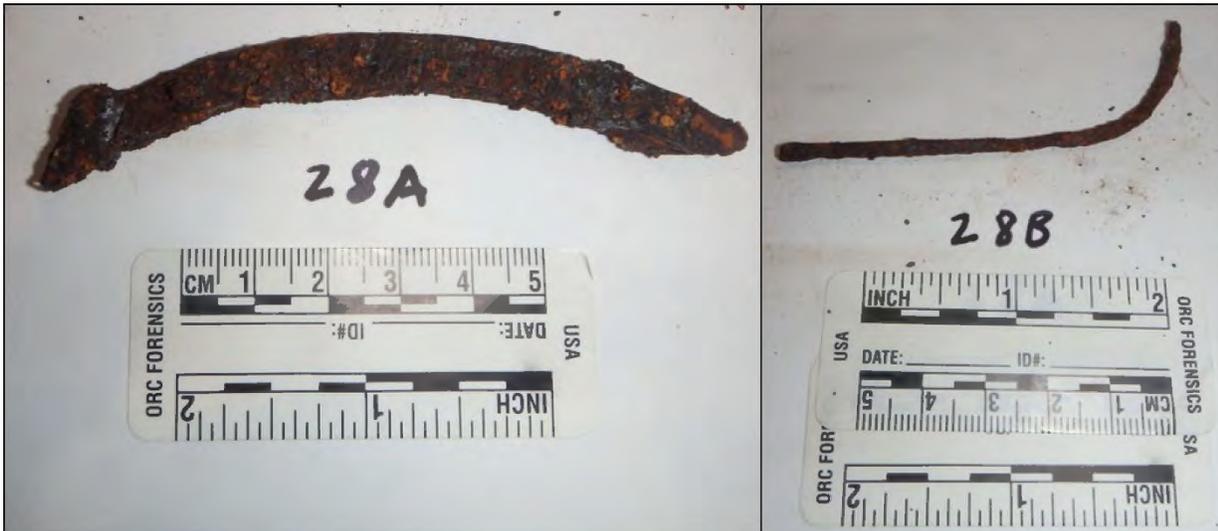
In addition to the black liquid, two pieces of metal were found to be embedded at the inlet end of the brine tube sheet. (See Figure 21.) Laboratory testing determined that the metal parts were a piece of metal (labelled 28A) with the same chemical content consistent with ASTM A53 grade B pipe and a piece of malleable wire (labelled 28B) with the same metallurgical properties as MIG-type welding wire.

Figure 21: Two metal pieces found at the inlet end of the curling rink brine tube sheet.
(Source: Forensic Engineering Report from Acuren Group Inc. — Appendix C)

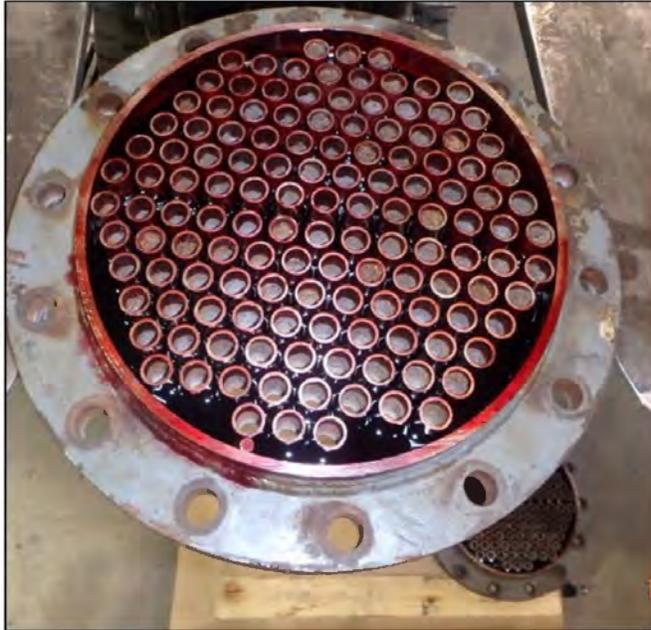
The end plates were removed from both ends of the tube bundle. Leak tests using penetrating dye determined that no leaks were present where the tubes were mechanically joined to the tube sheet plates. The tube sheet plates were cross-sectioned at the mechanical rolled joints. No manufacturing error or leaks were detected at these locations. (See Figures 22 and 23.)

Figure 22: The cross-sectioned tube sheet in the foreground; the second sheet is in the lower right corner of this photograph, with the ammonia pressure shell end facing up. A red penetrating dye bath has been added to test for permeation through the tube sheet. (Source: Forensic Engineering Report from Acuren Group Inc. — Appendix C)

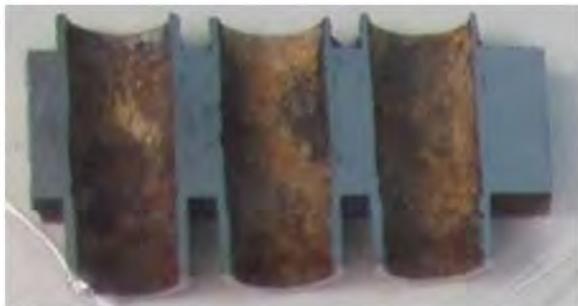
Figure 23: Three brine tubes cross-sectioned at the tube plate. Examination showed good mechanical connection of the rolled tubes with no evidence of leaking.

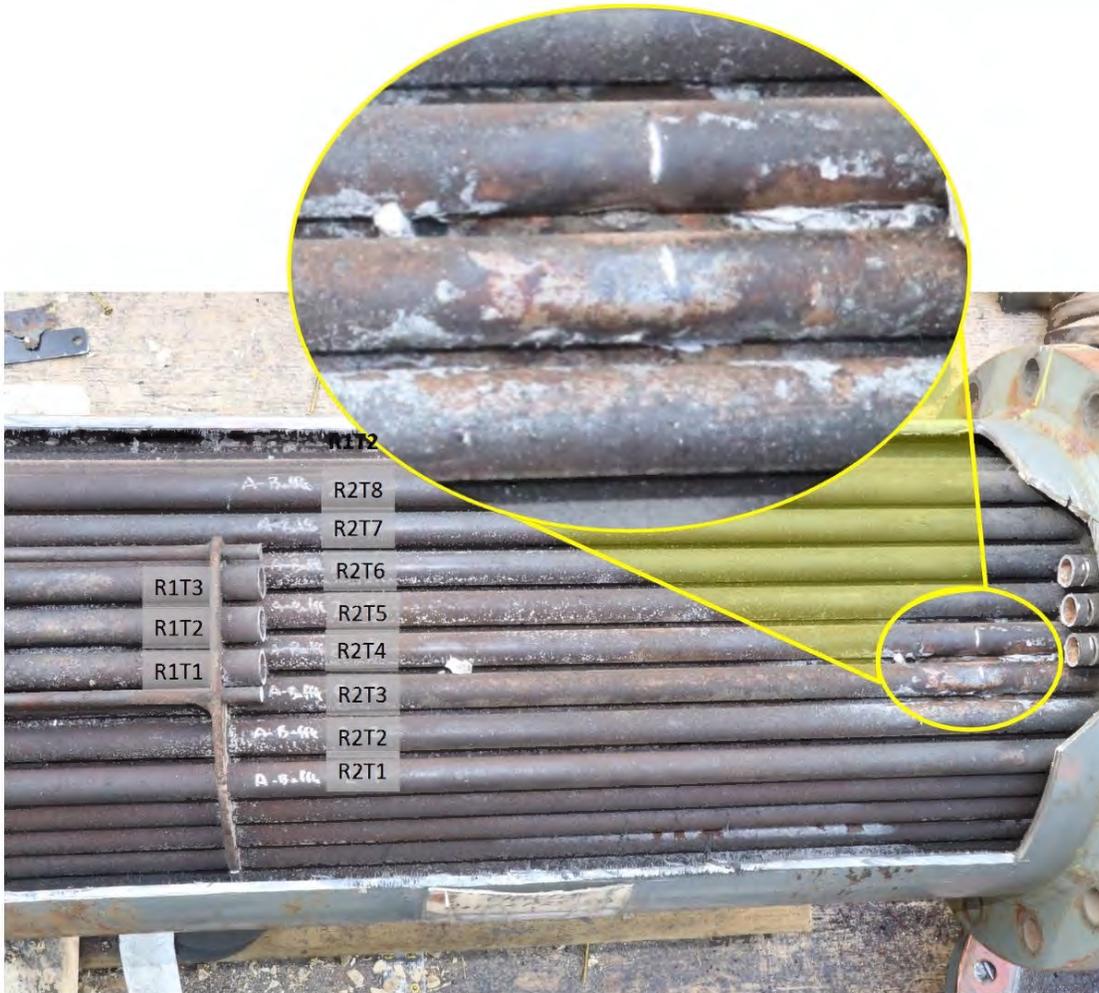
Investigators observed unusual corrosion patterns that appeared to originate from the third tube of the second row. (See Figure 24.)

Figure 24: Photograph with close-up showing radial patterns and corrosion in the second row of brine tubes at the outlet end of the curling rink chiller.

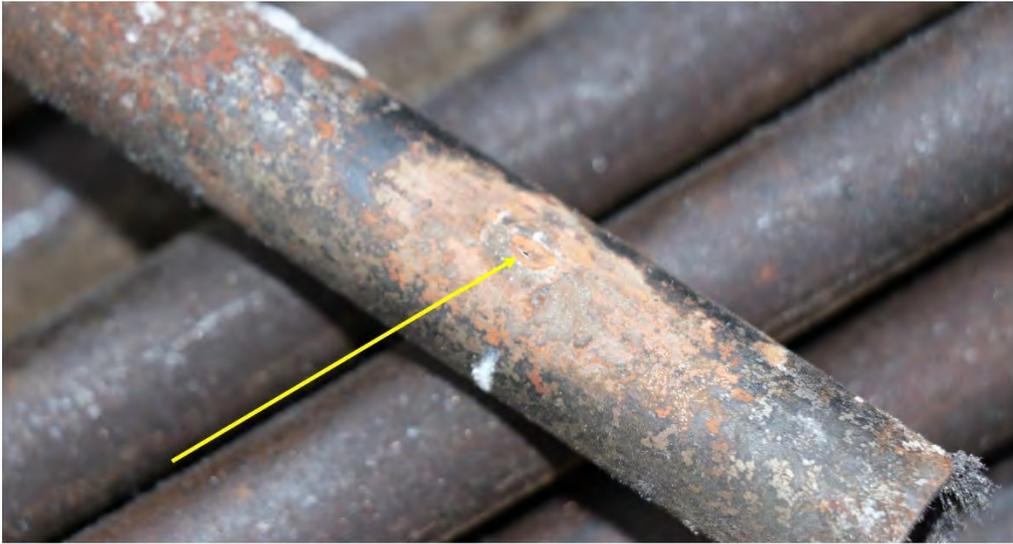
Figure 25: Photograph showing brine tube R2T3 after removal from the tube bundle. WorkSafeBC investigators observed a small hole in the tube (yellow arrow).

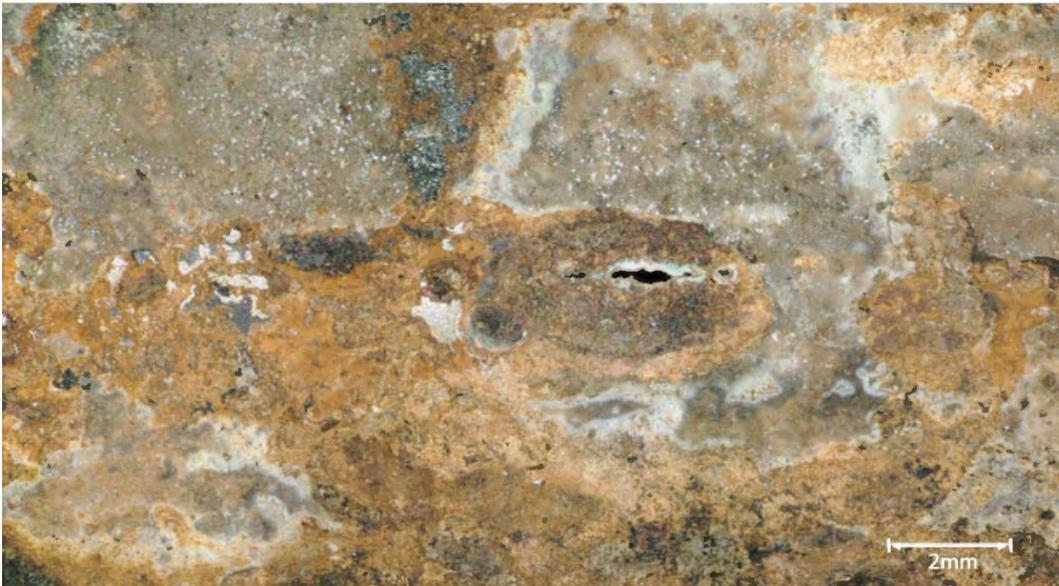
Tube R2T3 was extensively examined. (See Appendix C: Forensic Engineering Report — Acuren Group Inc.) The breach was characterized by a series of corrosion holes comprising an oval-shaped area approximately 2.2 millimetres in length. (See Figure 26.) The entire volume of ammonia that led to the deaths of the three workers in this case can be attributed to the loss of containment of the ammonia through this relatively tiny hole.

Figure 26: Close-up of the exterior of tube R2T3, showing the hole that allowed ammonia to enter the brine circulation system. (Source: Forensic Engineering Report from Acuren Group Inc. — Appendix C)

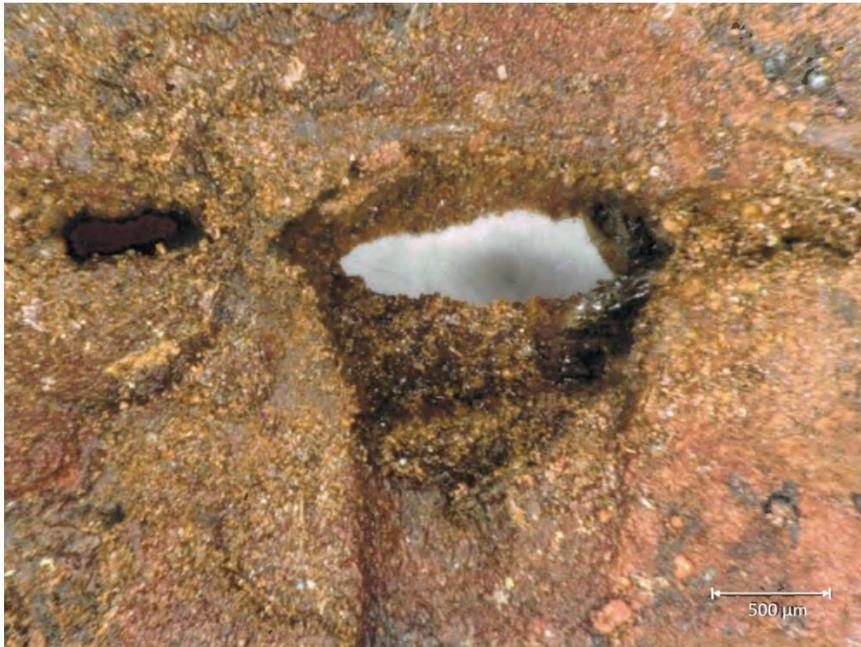
Analysis conducted at the forensic testing laboratory determined that the breach in tube R2T3 was orientated at the 4 o'clock position on the tube, and began on the brine side (inside) of the tube and progressed outward. (See Figure 27.)

Figure 27: Close-up of the hole from the inside of brine tube R2T3. Scouring from the flow/jetting of material into the brine tube can be seen directly below the hole. Other pits have developed on both sides of the breach.
(Source: Forensic Engineering Report from Acuren Group Inc. — Appendix C)

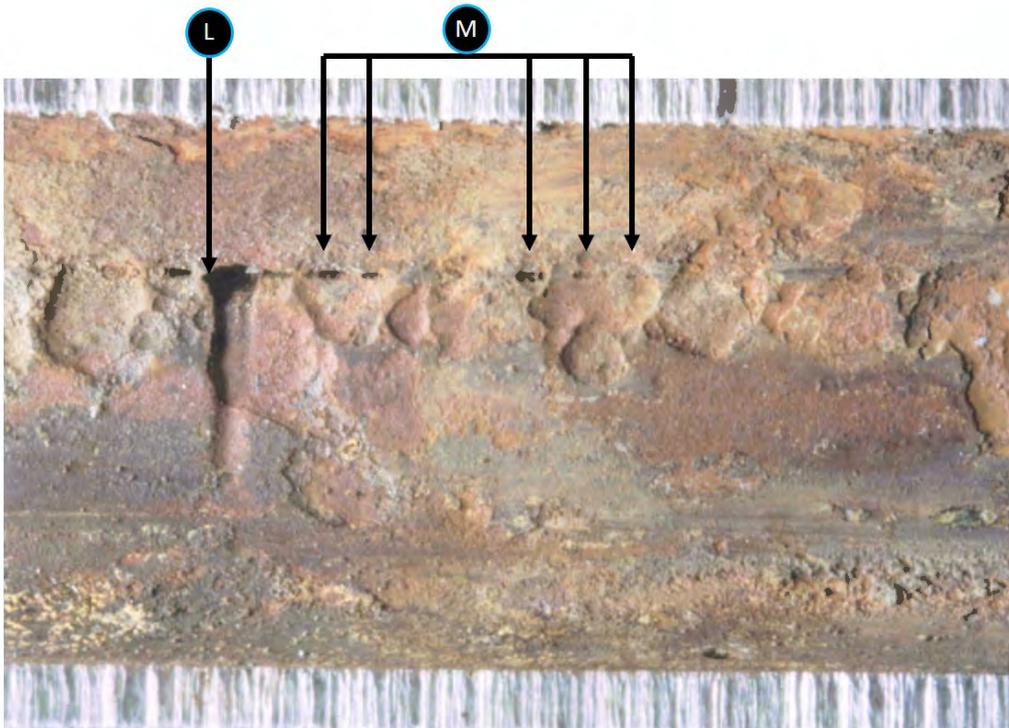
Prior to the creation of the breach, a series of small corrosion holes, or pits, had developed. The pits were of varying depths and had formed in a near-perfect straight line along the length of the tube. The holes were also arranged in groups, so that the line of corrosion presented a pattern similar to stitches made by a sewing machine, or a zipper. (See Figure 28.) This type of pitting is referred to as *preferential corrosion* in this report.

Figure 28: Interior view of brine tube R2T3 after it was cut horizontally. The breach hole (L) is aligned horizontally with other pits that have not corroded all the way through the brine tube (M). (Source: Forensic Engineering Report from Acuren Group Inc. — Appendix C)

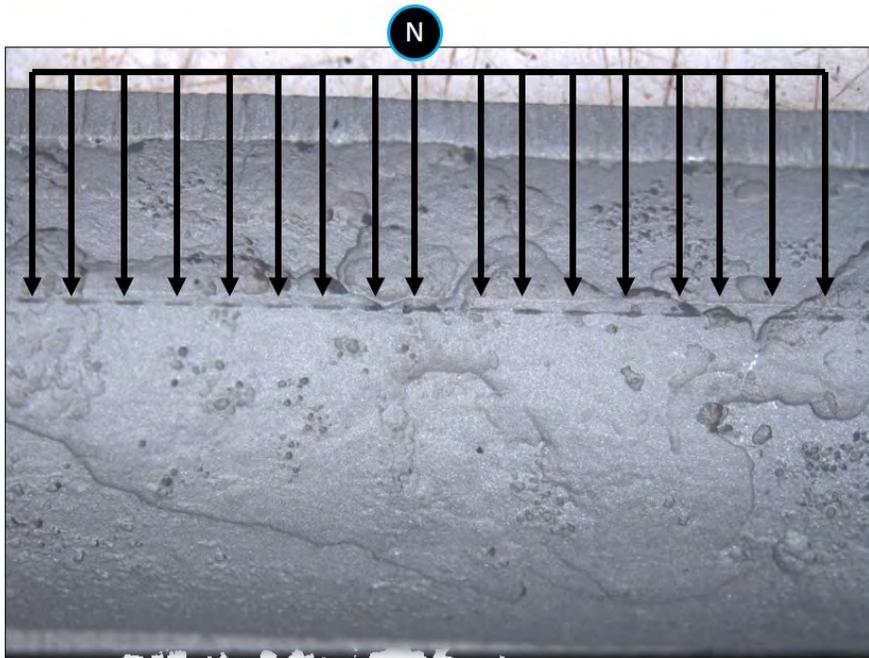
The same effect was also observed in other tubes from the curling rink chiller. The line of pitting was not orientated in any specific direction relating to their installation position in the tube bundle (that is, top, bottom, left, or right). Instead, the pitting was observed to be aligned along the length of each tube, at the seam welding for the tubes. (See Figure 29.)

Figure 29: Interior of a different brine tube (R4T1) after it was cut horizontally and cleaned. A distinctive line of corrosion pits can be seen along the length of the tube interior (N). (Source: Forensic Engineering Report from Acuren Group Inc. — Appendix C)

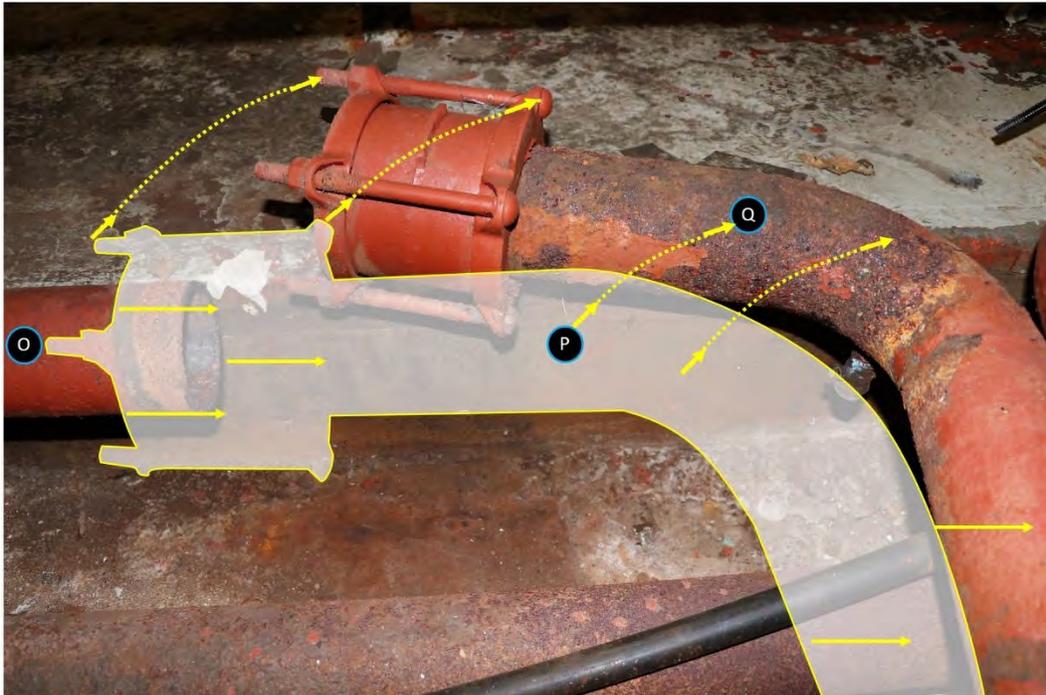
WorkSafeBC investigators also determined other components in the curling rink brine circulation system (for example, the brine filter connections and housing) could have failed at pressures below the opening pressure for the pressure-relief valves on the curling rink chiller. Since the system was not intended to handle the pressures it was exposed to as a result of the leaking ammonia, it can be stated that the pipe separation at the HC connection represented only the weakest link in the system's ability to withstand pressure in this case. If the pipe at the HC connection had held in place, it is possible that the stage 2 mechanical failure could have taken place in another part of the curling rink brine circulation system.

Figure 30: The separated HC fitting on the curling rink brine outlet pipe. The pipe separated because the process of ammonia leaking into the brine developed more pressure than the piping system was able to contain. The pipe section on the left side of the photograph (O) was embedded in the concrete slab and remained stationary. The HC and attached pipe section (P) were unrestrained. When the pressure increased, the HC and pipe section were able to move backward and rotate out of position substantially (Q), as observed by WorkSafeBC investigators after the event.
