HAZARD ALERT

Industry: Fishing

Area: Queen Charlotte Islands

Improper Chain Used in Overhead Rigging Kills Commercial Fisher

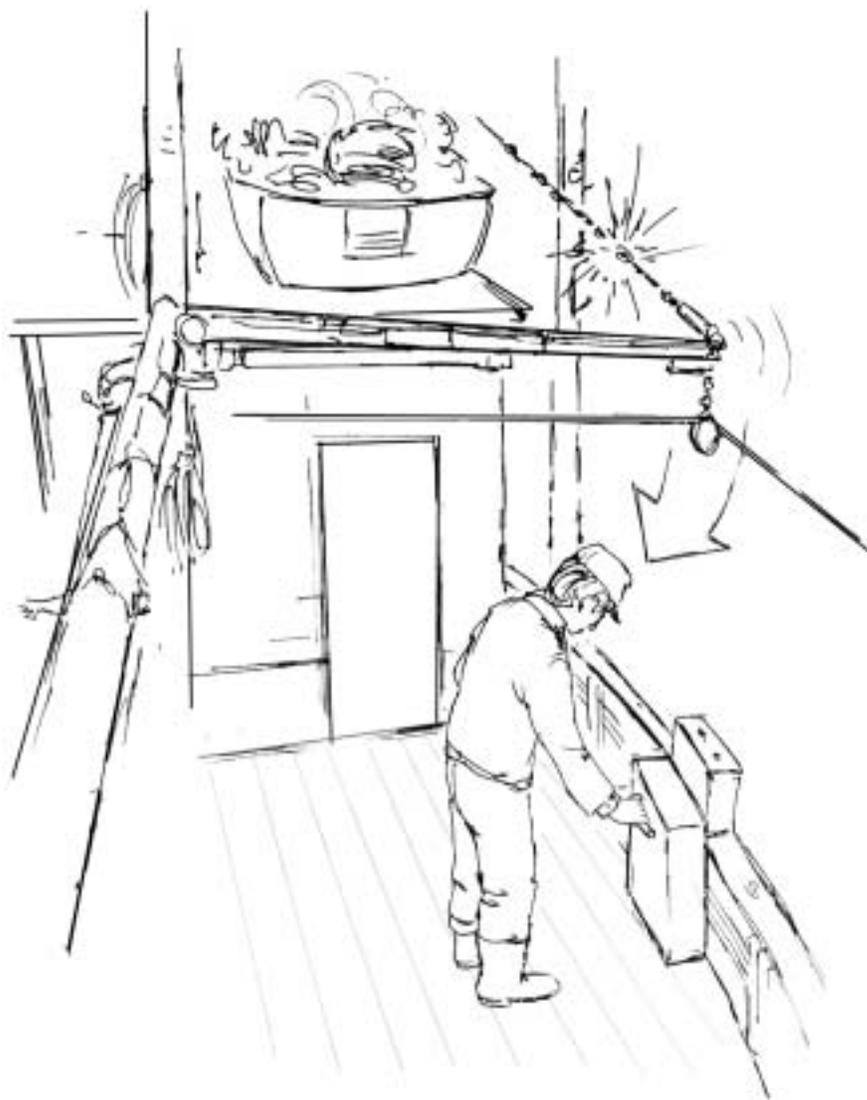
A longline vessel was participating in a fishery for rockfish and halibut. The crew were in the process of retrieving a string of gear when it became hung up on the ocean floor. The crewmember at the hydraulic winch controls attempted to remove the gear from the ocean floor by applying full power to the hydraulics. The strain on the rigging caused the jib boom, located directly overhead of the crewmember at the controls, to fall, fatally injuring the crewmember.

The vessel was rigged with an outboard block at the end of a jib boom secured from and perpendicular to the main boom. The jib boom was held in place by fore and aft wire rope stays. It was held horizontal by galvanized chain extending from the outboard end of the jib boom up to the main mast. The jib boom fell when a weld in a link in the chain failed. The chain used in the rigging was a $\frac{3}{8}$ -inch Schedule 30 (Grade 3) galvanized chain (commonly referred to as “Proof Coil” or “Proof Chain”). This chain is a high-carbon, non-alloy chain, which was not designed and is not recommended by chain manufacturers for overhead lifting.

- Ensure that all chain rigged for overhead lifting is approved and rated for that function, such as a Grade 8 or Schedule 80 alloy chain.
- Be aware of the intended use and rated capacities of ropes, chains, cables, fittings, and attachments when installing overhead rigging, including the compounding effect of triangulation.
- Ensure that workstation locations limit workers' exposure to injury should any part of the rigging fail.
- Whenever possible, replace overhead booms used to guide lines with outboard davits that would fall overboard should a failure occur.
