## Scissor Lift Hazard

WORKERS' COMPENSATION BOARD OF BC

Revised January 2005

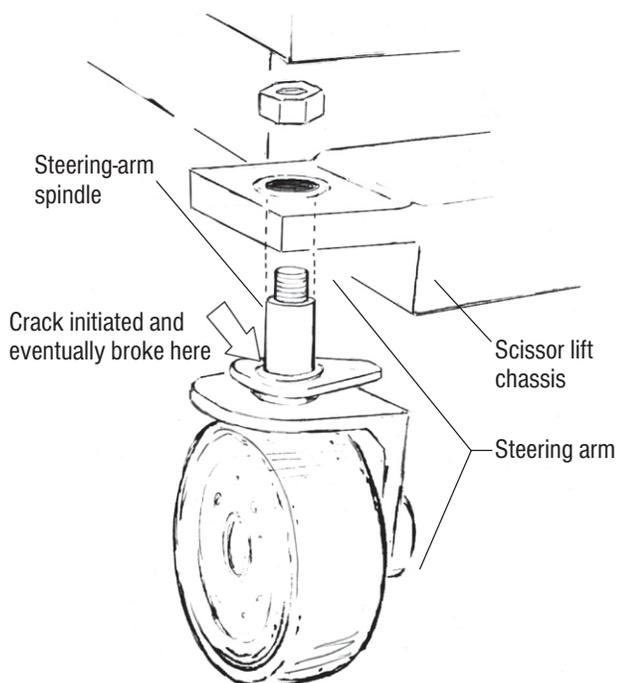
The scissor lift was a Marklift J25 EP unit with a capacity of 800 pounds and a maximum extension of 25 feet. It fell over because the left front steering arm, to which the left front wheel was mounted, had separated from the scissor lift chassis. The steering arm and steering-arm spindle are welded together, forming a complete unit. The steering-arm spindle had broken into two pieces, and the steering arm and wheel had fallen away from the chassis. As a result of the sudden loss of support at one corner of the chassis, the scissor lift toppled over.

Examination of the broken spindle showed a small fatigue crack located at the spindle root radius (the point where the spindle joins the steering arm). The spindle remained straight – it was not bent after the sudden failure – and the fracture surface was consistent with that of a brittle fracture resulting from a single overload. The location and small size of the fatigue crack would have made it impossible to see the crack without removing the steering arm from the machine.

Equipment rental and servicing companies and all other owners of Marklift J25 EP and Terex TS30 and TSM30 scissor lifts must inspect the steering-arm spindles on these units to ensure that there are no cracks at the spindle root radius. To conduct the inspections, remove the steering arms from the machine and use the magnetic particle technique or other effective non-destructive testing method. The magnetic particle technique enables cracks to be distinguished from other markings on the spindle. Steering arms with cracks in the spindle must be replaced with the appropriate replacement part from the manufacturer where possible, or, if no replacement part is available, with a suitable device designed by a professional engineer.
