# HAZARD ALERT

## Worker dies after contacting energized conductor

FATALITY  
02-02

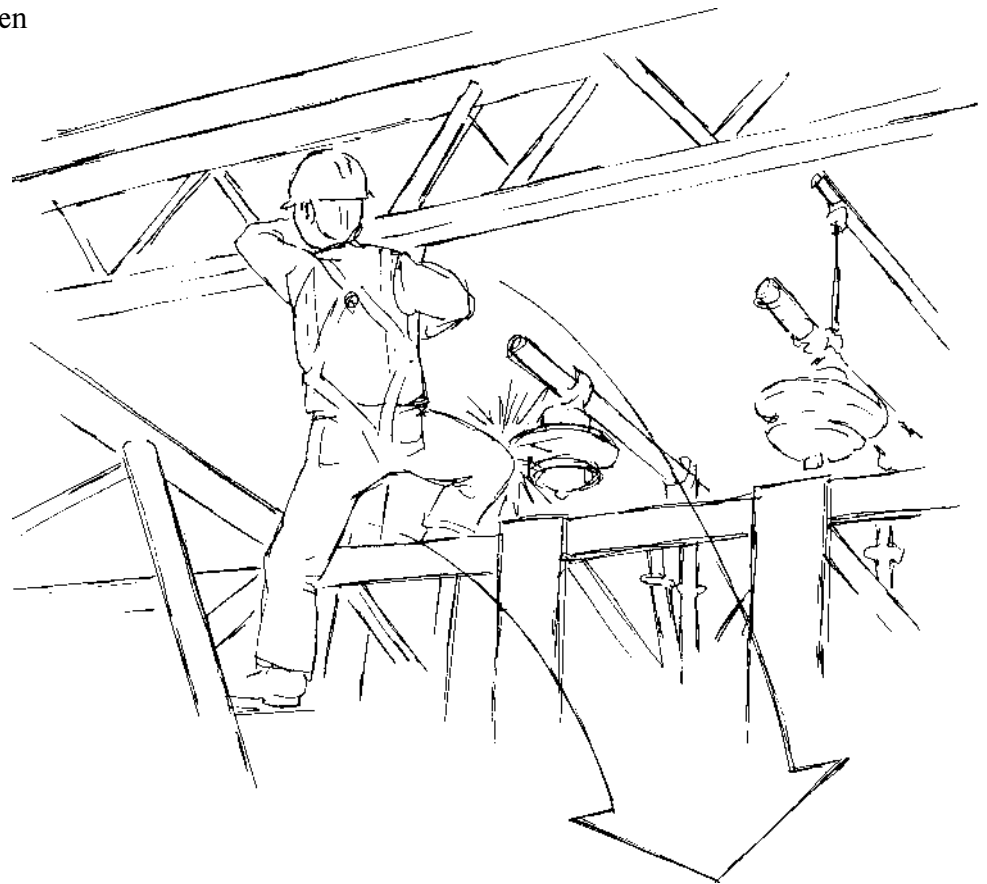
Electricians were repairing and cleaning insulators at an outdoor electrical substation. Workers first followed written group lockout procedures to de-energize and lock out the half of the substation where work was to be done. However, a nearby 13,800-volt busbar was still energized because it was not apparent that the other half of the substation supplied this conductor. An electrician contacted the energized busbar as he was climbing down a supporting column and fell 3 m (9 ft.) onto concrete. He suffered fatal internal injuries.

An investigation revealed that the written lockout procedure did not include isolation of all energy sources. There was no visual check of the physical plant to verify that all electrical equipment and sources of energy were identified in the lockout procedure.

- Include all sources of energy in written lockout procedures.
- When lockout procedures are developed, do a physical check to ensure that every piece of equipment and all sources of energy are identified.
- Ensure electrical line diagrams are accurate and reflect the location of electrical conductors.
- Undertake physical testing to ensure grounding and isolation are effective.
- Hold a pre-job safety meeting before starting work on high-voltage equipment.
