INCIDENT INVESTIGATION REPORT	
Type of occurrence Explosion	
Notice of incident number 2014140710119	Incident outcome INJURY x 3
Location of incident Pinnacle Pellet Plant 22075 Hwy 16 East Burns Lake, B.C.	Lead investigator Brent Farnsworth
Approved by manager, Fatal and Serious Injury Investigations Kenneth Bradley	Date October 26, 2015
PARTIES INVOLVED IN INCIDENT	
Employer	Name and address Black Fox Enterprises Ltd. 20053 Farewell Creek Road Telkwa BC V0J 2X2
Workers	Employer ID 769543
	Industry classification 764028 Heavy Equipment, Machinery, or Parts Sales, Rental, Service, or Repair
	Occupation Labourer
	Injured
	Injured
	Injured
Employer	Name and address Pinnacle Renewable Energy Inc. Unit 350 3600 Lysander Lane Richmond BC V7B 1C3
	Employer ID 867025
	Industry classification 714019 Pressed Board Manufacture
Employer	Name and address Advanced Millwright Services Ltd. PO Box 1743 Vanderhoof BC V0J 3A0

On October 9, 2014, during maintenance shutdown at a wood pellet plant, three workers were standing at the opening of a burner door when an explosion occurred in the dryer system. The three workers were knocked backwards by the force of the explosion and suffered burn injurie

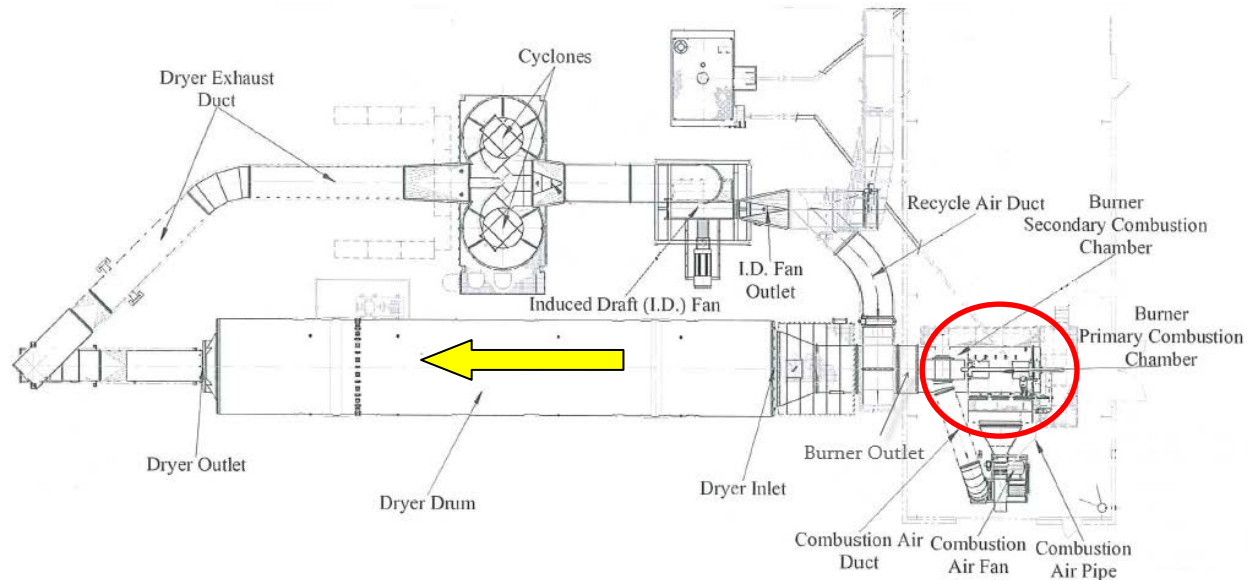
Figure 1: Plan view of the no. 1 dryer system. The burner is circled. The yellow arrow indicates the direction of the flow of the wood waste. (Source: Pinnacle Renewable Energy Inc.)

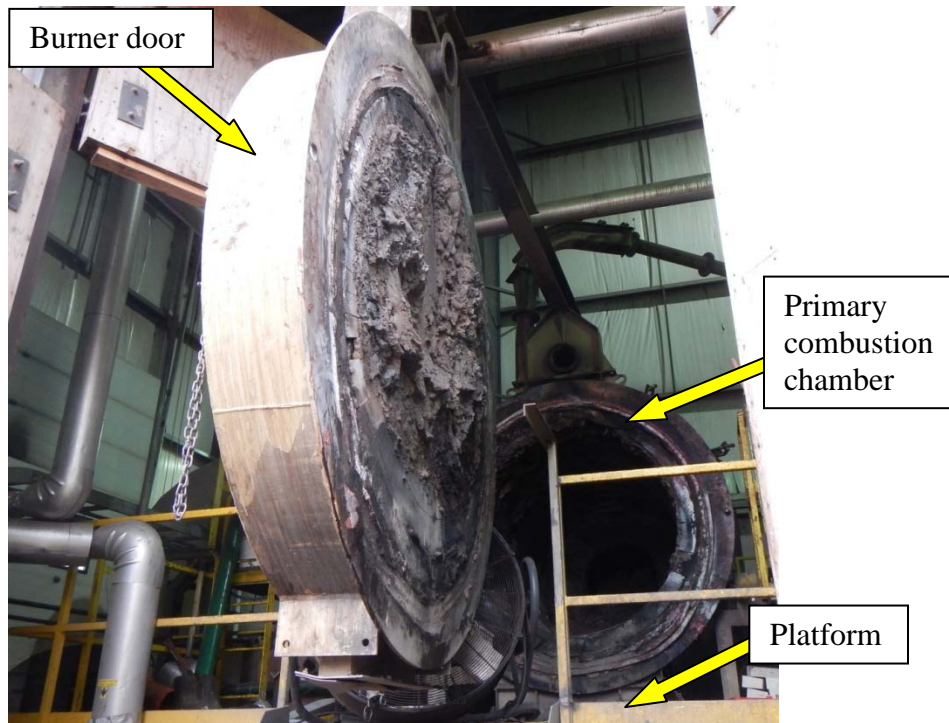
At 07:31, two Pinnacle labourers unbolted the dryer no. 1 burner door, removed it from the burner, and slid the door out of the way to allow worker access in preparation for cleanout of the interior of the combustion chamber (see Figure 2). The burner outlet temperature was recorded as being 358°C. The Production Superintendent went down to inspect the condition of both burners and to verify the burner lockout prior to cleanup.

Figure 2: The opened door of dryer no. 1's burner and its primary combustion chamber.

[REDACTED] He stated that the control room provides the burner temperature before the door to the burner is removed, but the burner outlet temperature at 07:31 was still 358°C when the no. 1 burner door was unbolted.
