## Overhaul ball falls from crane, striking worker

Number: 2005112130133

Core activity: Pile driving

Date: June 2005

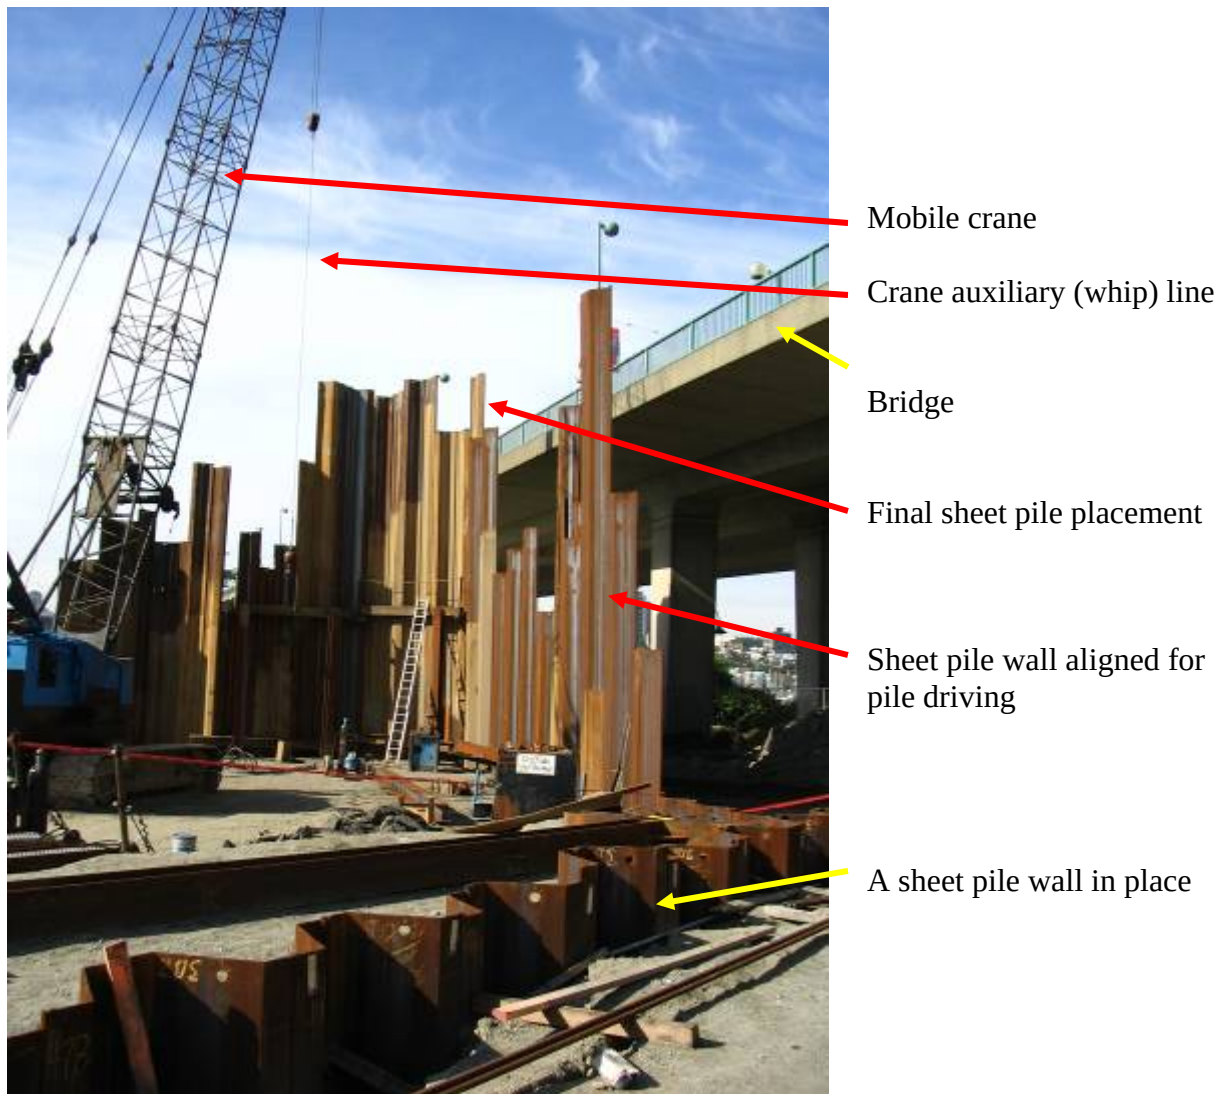
Photo 1: The worksite where the fatal incident occurred.

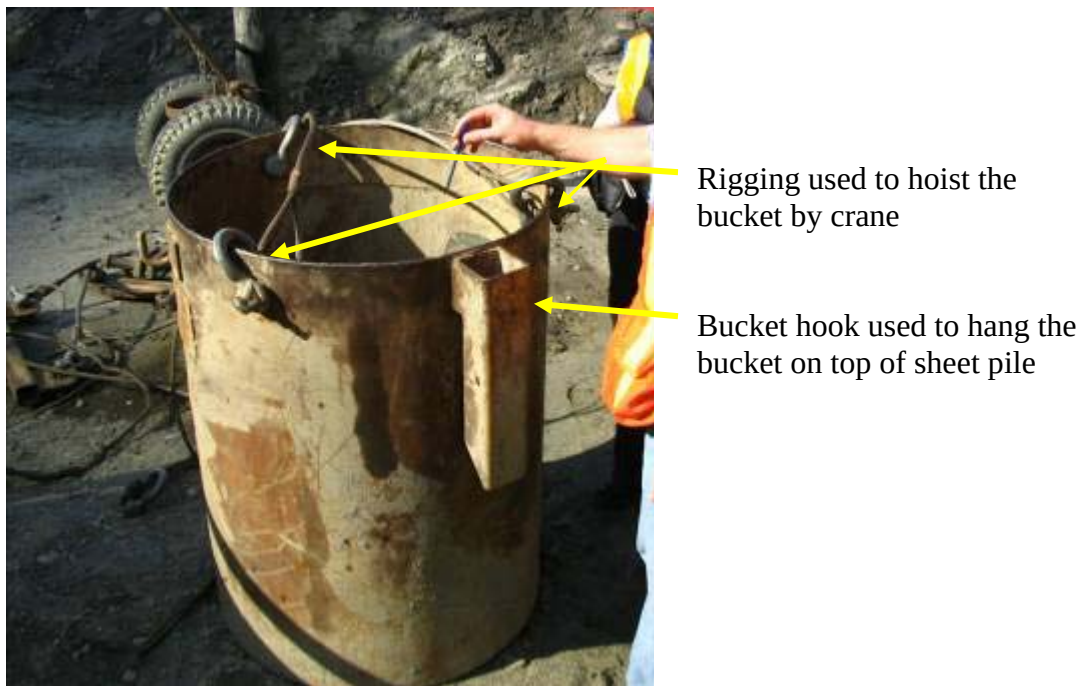
Photo 2: The photo shows the type of work bucket that was hooked onto an adjacent pile while the next pile was lowered into position.

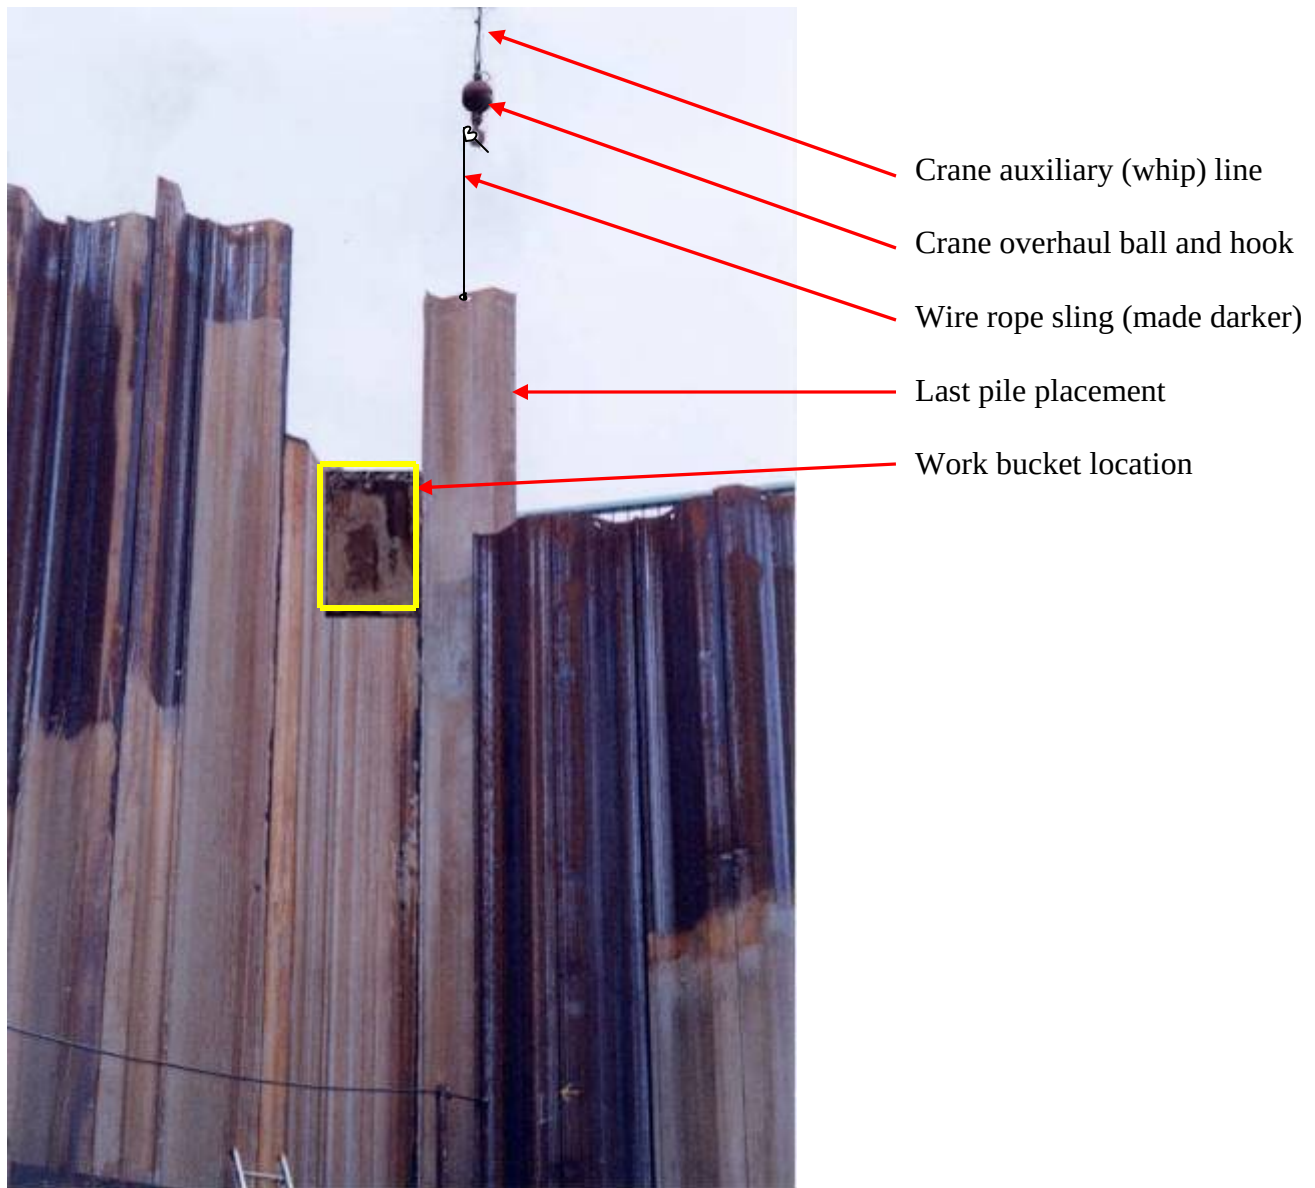
Photo 3: Sheet pile placement.

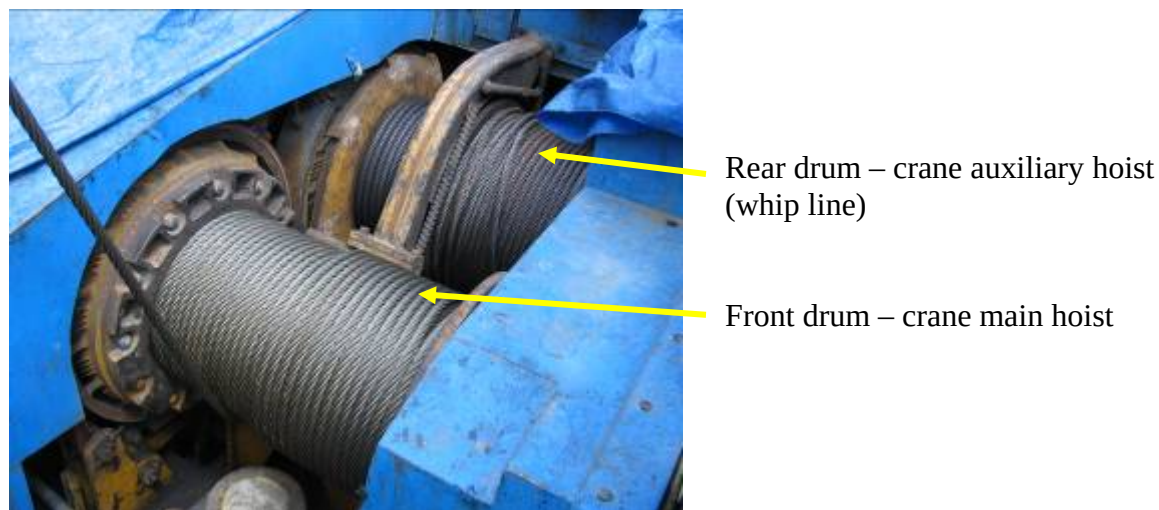
Photo 4: The crane hoist drums. On the day of the incident, only the rear drum was used.

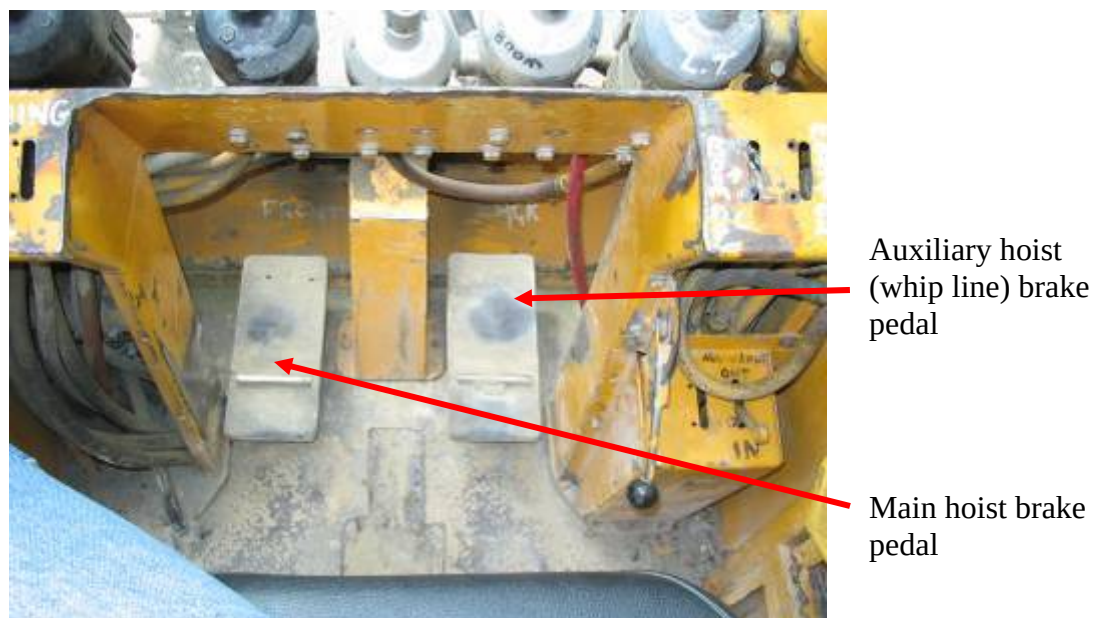
Photo 5: Brake pedals in the cab of the mobile crane.

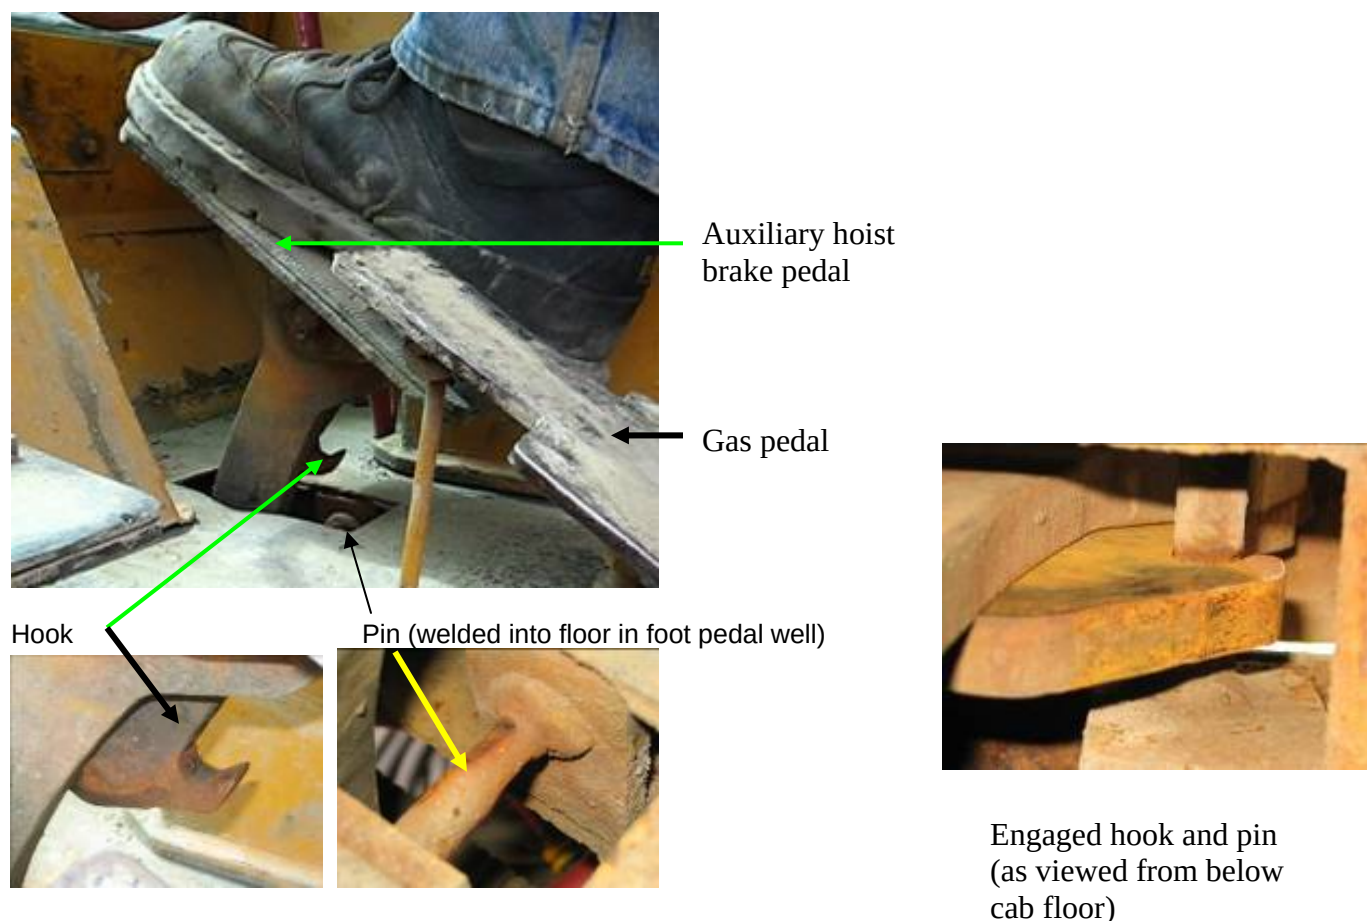
There is a mechanism (a hook and pin) for latching the pedal in the down position, when the brake is fully applied (see Photo 6). The hook and pin are engaged by pushing the pedal to the floor, toeing forward, and releasing the pedal. When the hook and pin are engaged, the operator can remove the foot from the pedal and have the rear drum friction brake remain applied. On the crane involved in the incident, the friction brake is the only braking system for the auxiliary hoist (whip line).

Photo 6: Pedal latching mechanism.

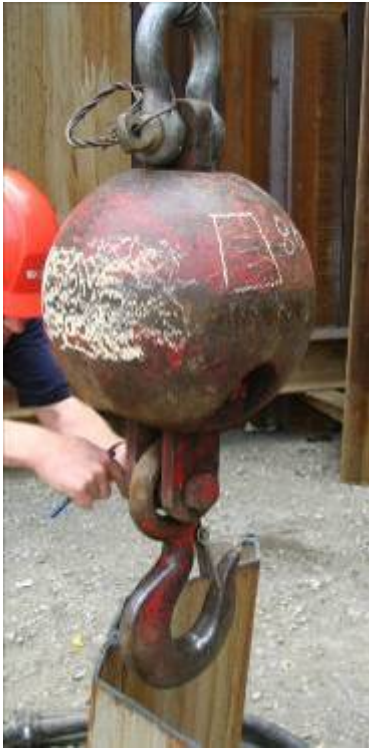
The working end of the auxiliary hoist (whip line) is equipped with a steel overhaul ball and load hook weighing an estimated 500 to 600 pounds (see Photo 7). The overhaul ball provides a weight to keep tension on the auxiliary hoist when there is no load on the hook. This ensures the line spools and unspools properly on the rear drum.

Photo 7: Overhaul ball and load hook.

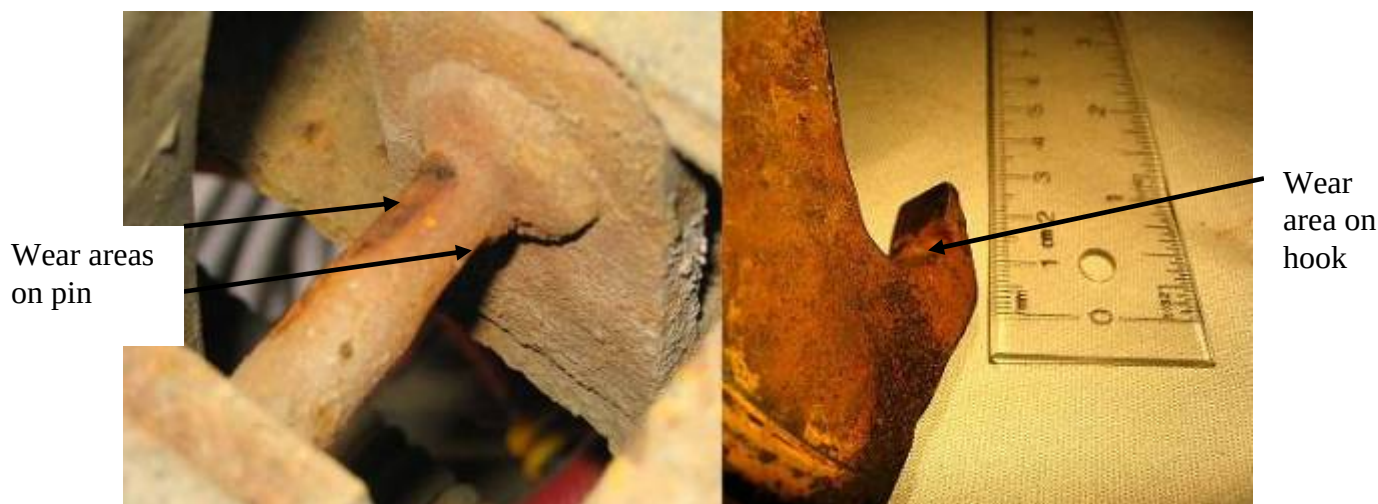
The auxiliary hoist brake pedal was removed for inspection by WorkSafeBC. Some wear was found on the hook and pin of the pedal latch mechanism (see Photo 8).

Photo 8: Wear on the pin and hook of the brake latch mechanism.

The pin and hook, which are critical components of the crane's braking system, were not inspected as part of routine inspections. Braking components were badly worn, although no components had failed.

- The auxiliary hoist brake pedal assembly that included the worn pin and hook was replaced.
- An ergonomic (human factors) assessment was done by the employer. Several recommendations were made including an assessment of all the company's cranes for force measurements and recommendations concerning the inspection and maintenance of crane controls.

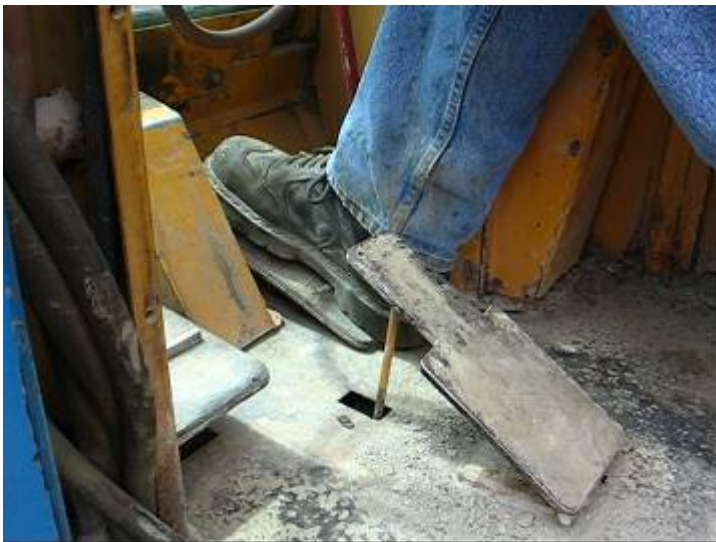
Photo 10: To latch the brake, the heel is first pressed to the floor.

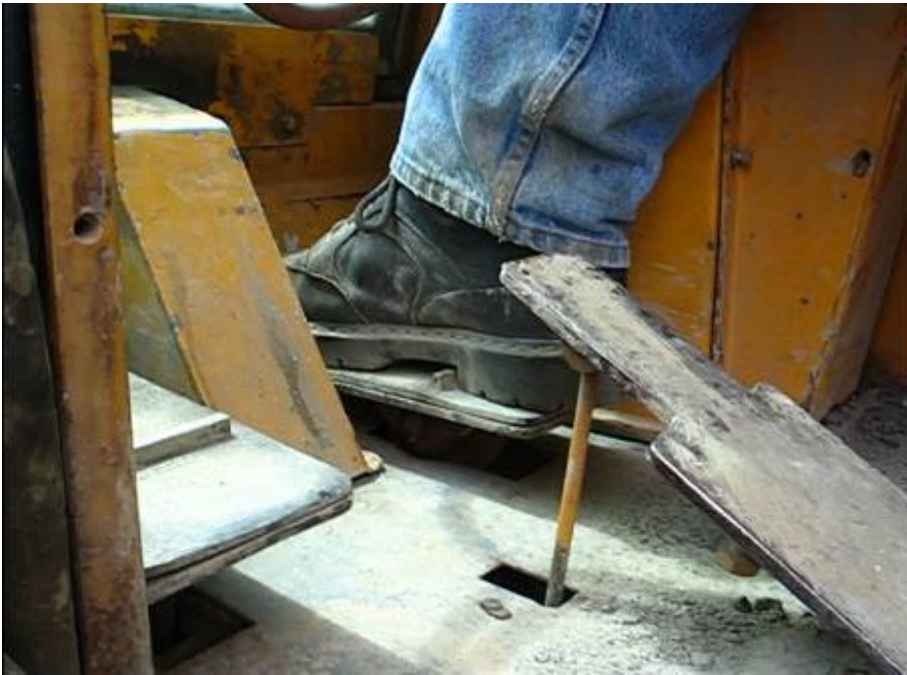
Photo 11: When the ball of the operator's foot presses down on the front end of the pedal, the back of the pedal rises, putting the pedal in a horizontal position.

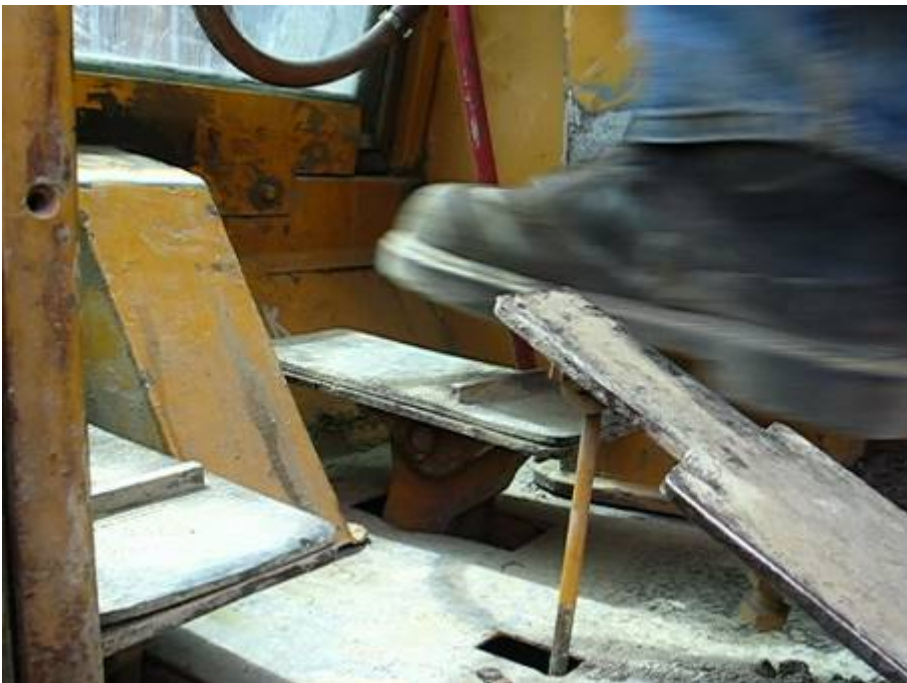
When locked, the pedal rises 3.5 inches to the horizontal position. This indicates that the pedal cannot rise any further and the hook and pin are fully engaged (see Photo 12).

Photo 12: The pedal is properly latched and the foot can be removed.

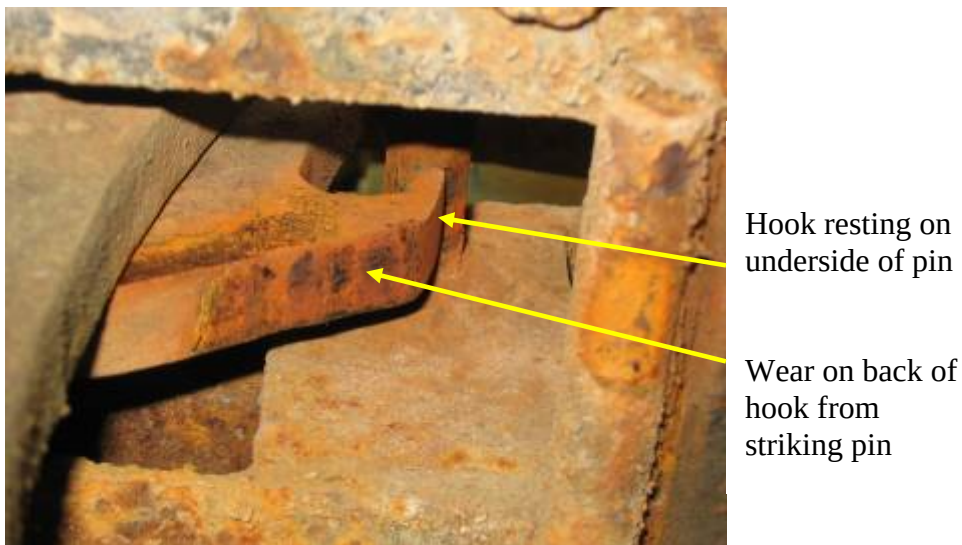
During the examination of the auxiliary hoist brake pedal, one issue surfaced. When a crane operator attempts to latch the pedal, the hook can come to rest on the underside of the pin, giving the impression (and sound) that the hook has fully engaged the pin (see Photo 13). This can occur if the pedal does not completely or sufficiently complete stage 2 (ball of the foot moving the front of the pedal down). In this configuration, the hook will readily slip off the pin when the operator's foot leaves the pedal. It may engage or disengage the latch, depending on the direction the hook moves relative to the fixed pin. During the examination of pedal functioning, this particular pedal action could be reproduced only intermittently.

If the ball of the foot pushes down on the front of the pedal too soon while engaging the brake, the back of the hook will strike the pin before the pedal reaches the bottom of its travel. The pedal will release immediately as the latch is not engaged.

Photo 13: The hook is resting on the underside of the pin rather than being fully latched under the pin. In this position, the brake pedal may release when the operator's foot is removed.
