INCIDENT INVESTIGATION REPORT

Type of occurrence Motor vehicle incident (MVI)		
Notice of incident number 2017178040008	Incident outcome Fatality (1)	Date of incident August 14, 2017
Location of incident Film set Vancouver Convention Centre 1055 Canada Place Vancouver, B.C.	Primary investigator Lance LABBY	Investigation file number FSI-REG-2017-0099
Approved by manager, Fatal and Serious Injury Investigations Jeff YOUNG	Signature

Date Sept. 24, 2019

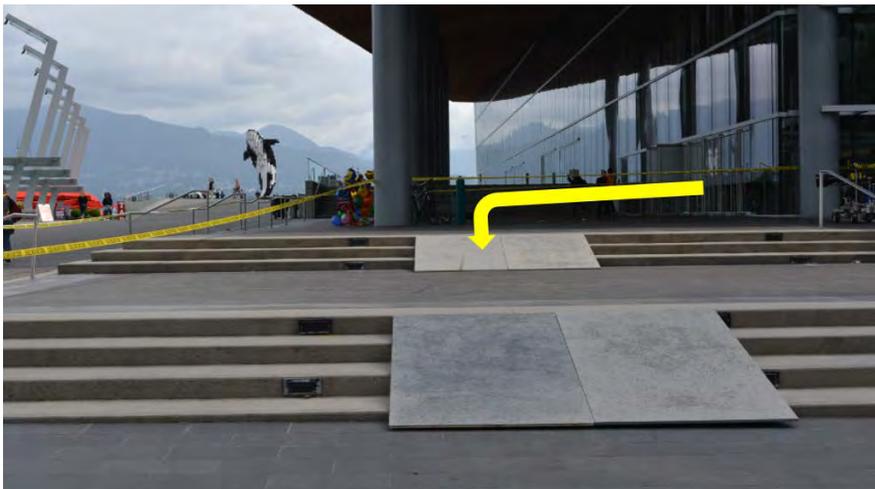
During the rehearsals on the date of the incident, a second wooden transition ramp was added to the second set of stairs. The second transition ramp was intended to provide the Operator with more distance to safely stop the motorcycle at the conclusion of the shot.

Figure 1: Photograph facing north, showing the film set with the two transition ramps. The arrow indicates the Operator's intended path of travel.

After a discussion between Stunt Person 4 and Stunt Coordinator 2, a second transition ramp was installed to provide the Operator with more distance to slow and avoid unsafe braking before stopping. No barriers were put in place.

The second transition ramp was not part of the initial planned design; it was installed during the rehearsals after the Operator was observed stopping in an unsafe manner on the first transition ramp. The second transition ramp was intended to increase the Operator's stopping distance, which would in turn eliminate the need to stop the motorcycle in an unsafe manner to avoid the second set of stairs. However, this did not take into account the fact that the addition of the second transition ramp might allow the Operator to approach the first transition ramp at a speed great enough to cause the motorcycle to become airborne. A flat deceleration area would have removed the need to transition to another level and would have prevented the loss of control that resulted in this incident.

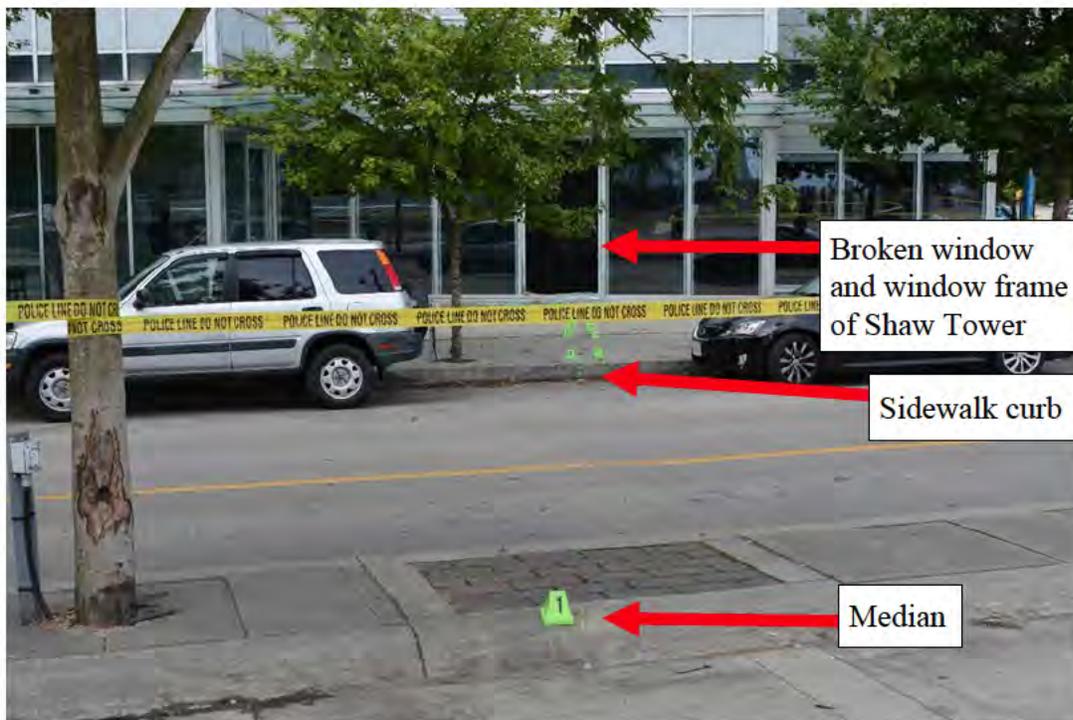
The Operator was hanging onto the handlebars as her body bounced off the motorcycle seat; her feet were completely off the foot pegs. The motorcycle continued, struck the median on the road, and ejected the Operator. The Operator struck the branches of the tree on the sidewalk and then crashed through a window of Shaw Tower, striking her head on the window frame. (See Figure 2.) After the Operator was ejected, the motorcycle continued on until it collided with the sidewalk curb, destroying the front wheel. The motorcycle then slid into the side of Shaw Tower and came to rest on the sidewalk.

Figure 2: Photograph facing south, showing the median (with VPD marker 1); the curb of the sidewalk that the motorcycle struck; and Shaw Tower, which the Operator and the motorcycle struck. The distance from the median (marker 1) to the broken window on Shaw Tower is approximately 18 metres.

These actions caused the motorcycle and the Operator to accelerate off the second transition ramp and become airborne, resulting in a total loss of control. The motorcycle continued until it hit the median and ejected the Operator. After being ejected from the motorcycle, the Operator collided with the branches of a tree and then the window and window frame of Shaw Tower. The motorcycle collided with the sidewalk curb and then the side of Shaw Tower, where it came to rest on the sidewalk.

TCF failed to ensure that the workplace was designed with safety controls in place so that the Operator or the motorcycle could not proceed beyond the perimeter of the film set. Barriers were absent that should have prevented the Operator and motorcycle from leaving the set perimeter. During this incident, the Operator and the motorcycle she was riding left the perimeter of the set and narrowly missed members of the public prior to crashing into Shaw Tower across the street from the filming location.

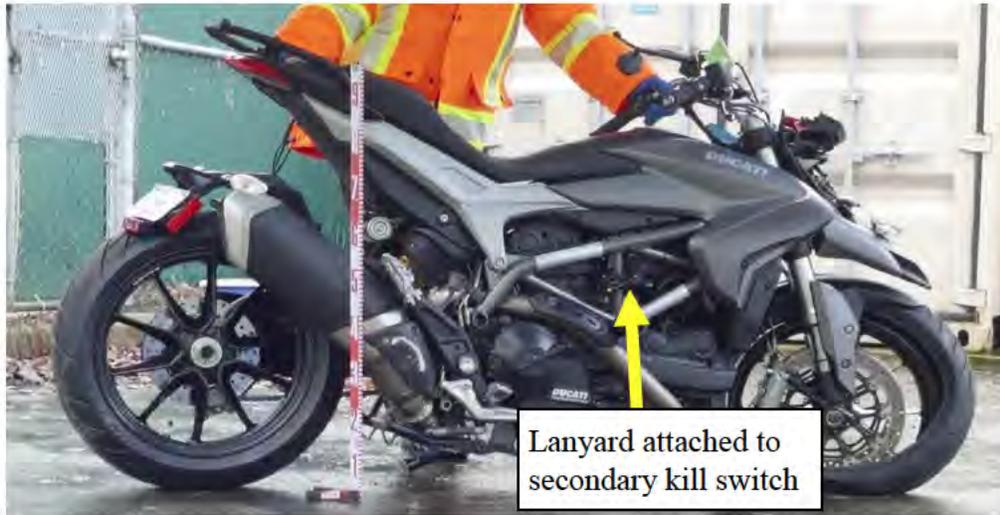
Picture Car Technician 1 explained during an interview that when he delivered the motorcycles to Mammoth Studios, he oriented Stunt Coordinator 2 and the Operator to the use of the kill switch. Stunt Coordinator 2 stated during an interview that he told the Operator to wear the kill switch lanyard. At the time of the incident, the Operator was not wearing the kill switch lanyard.

Figure 3: The motorcycle, showing the location of the secondary kill switch.

Each motorcycle was equipped with a standard kill switch on the right handlebar and a secondary kill switch on the right side of the motorcycle, with a lanyard attached. The Operator was not wearing the lanyard at the time of the incident. [REDACTED]

A post-incident examination of both kill switches found them to be in working condition and operating as intended.
