## Explosion during welding operation

A young worker was welding on the transom of an aluminum boat. Flammable vapour underneath the deck was not detected and an explosion occurred. The worker was thrown back about 10 to 15 feet (3 to 4.5 metres). The deck of the boat exploded upwards and hit the ceiling. The worker sustained injuries.

Number: 2010154850011

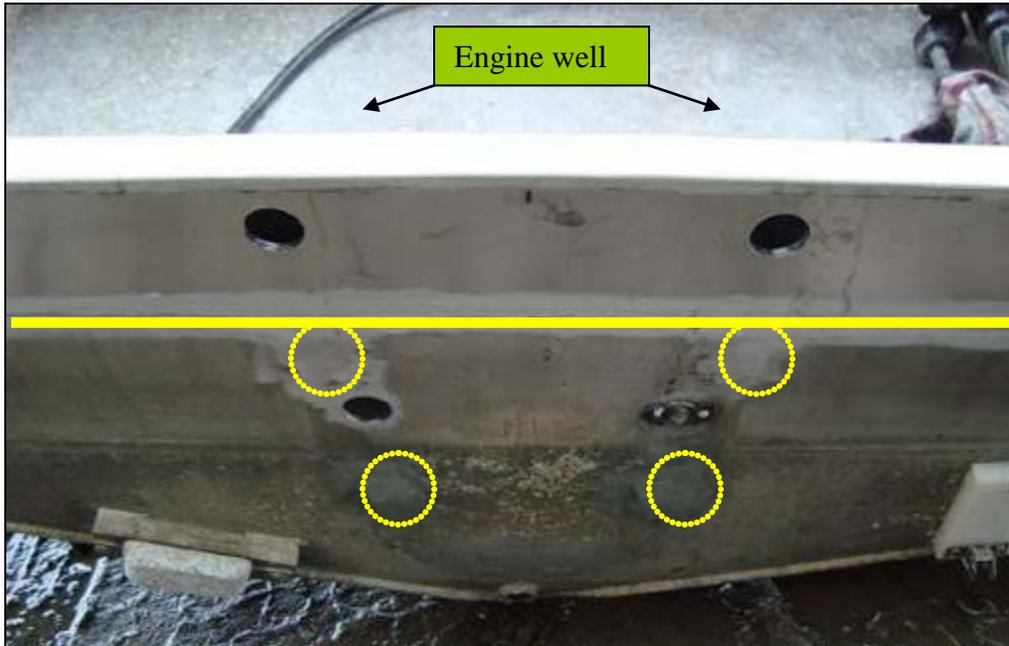
**Figure 1:** View of the exterior of the transom from the rear of the boat. The four circles indicate the original bolt-hole locations for engine mounting that the foreman plugged with aluminum. The horizontal line indicates the original top height of the transom. The aluminum added to the transom is above the horizontal line. Newly created bolt-holes made by the welder on the following day are visible.

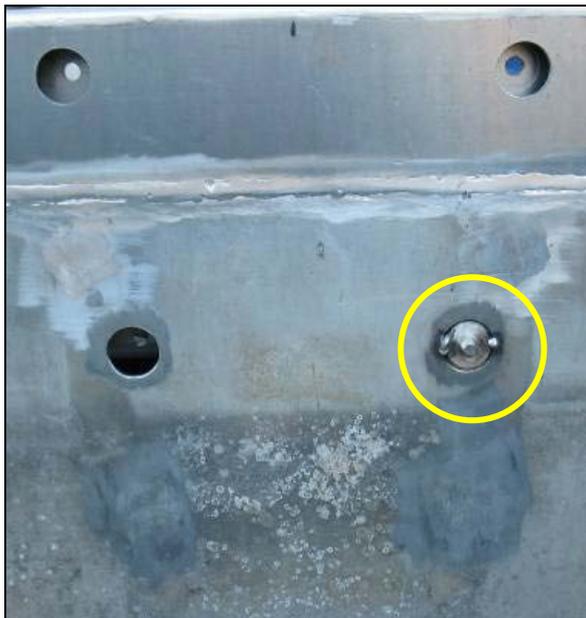
Bung inserted to create space for new bolt

**Figure 2:** Close-up view of the exterior of the transom. The first bung (circled) has been inserted and tack-welded into one of the four new bolt-holes.

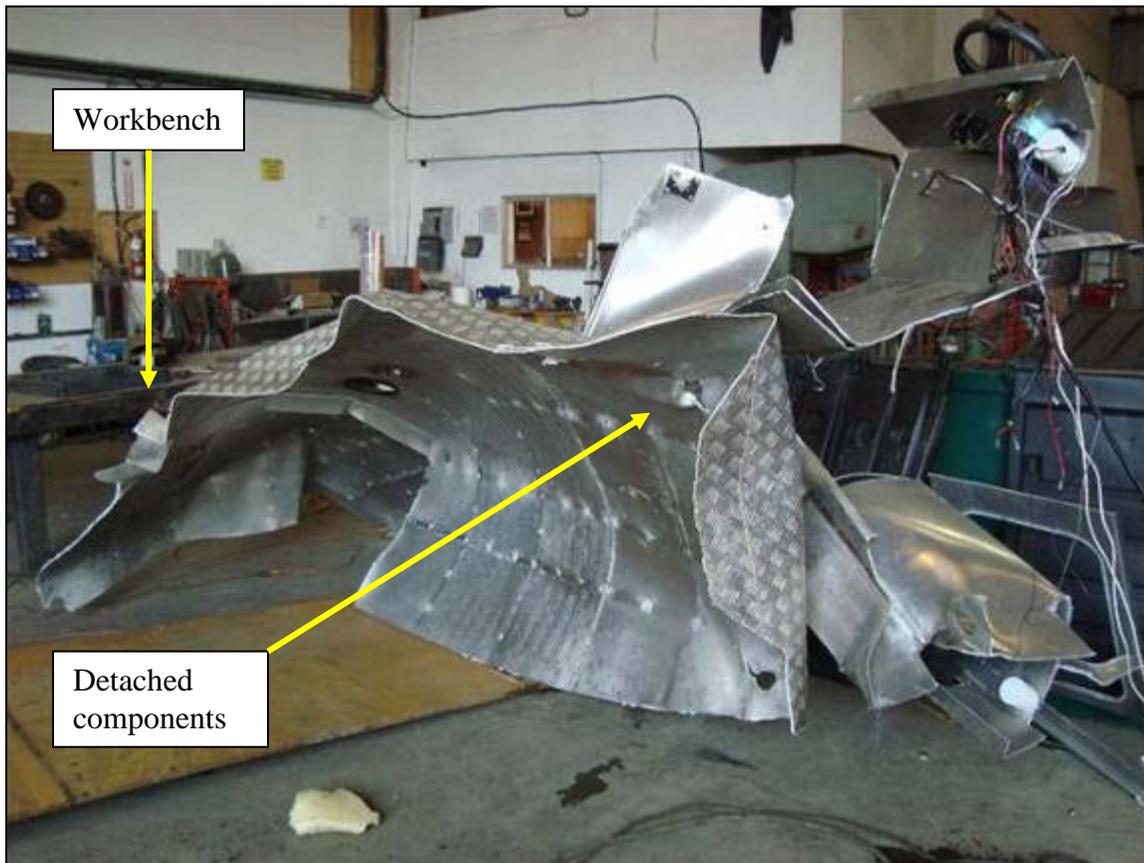
The welder had just started to weld the bung fully when an explosion occurred. The boat trailer and boat suddenly rose some distance above the floor, and then landed near where they had originally been. The welded-in deck, dashboard, and windshield detached from the interior of the boat. The detached components flew upward and struck the ceiling of the shop, near the light fixtures and an overhead natural gas heating appliance, before falling to the floor. (See Figure 3.) The ceiling was 25 feet (7.6 metres) high.

**Figure 3:** Photograph showing where the detached boat components fell after the explosion.

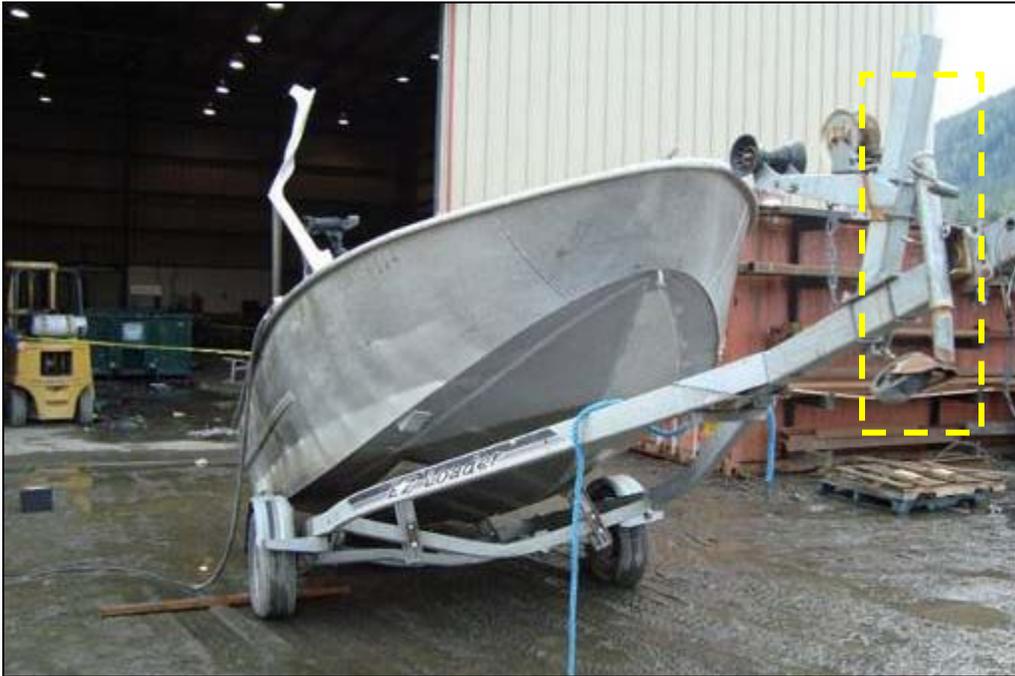
**Figure 4:** The boat and trailer parked outside the shop after workers wheeled the trailer through the overhead bay door. The damaged trailer jack and the bent small wheel components on the reach of the trailer are seen within the dashed rectangle.

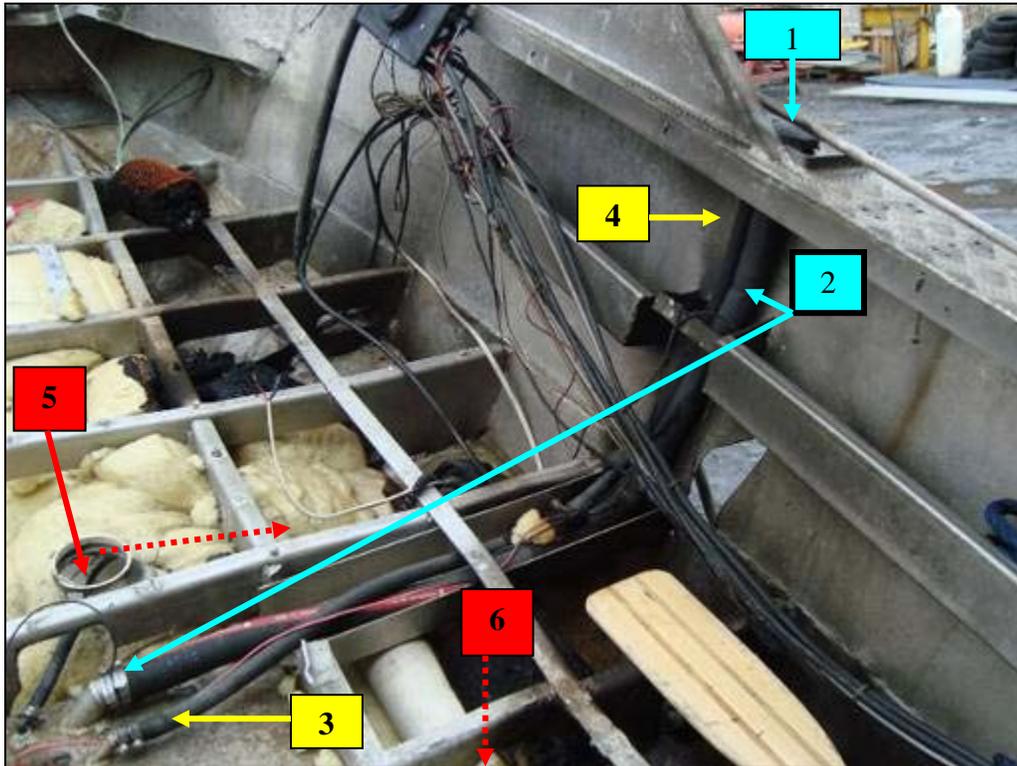
To fill the gasoline tank, a user would remove the fuel cap and insert a fuel hose into the large-diameter filler line located at the starboard gunwale of the boat. From the fuel tank, there are two other connecting hoses: a small-diameter ventilation hose that vents gasoline vapour to an outlet near the filler line cap, and a sending hose that delivers gasoline to the motor. The ventilation hose runs alongside the filler line (see Boxes 3 and 4 in Figure 5).

**Figure 5:** Box 1 indicates the fuel cap on the starboard gunwale of the boat. The vapour ventilation outlet is adjacent to the fuel cap. Box 2 and its arrows indicate the intake portion of the filler line and the filler line connection to the fuel tank. Box 3 indicates the ventilation hose connection to the fuel tank. Box 4 indicates the ventilation hose near the vapour exhaust outlet. Boxes 5 and 6 indicate the sending hose. The sending hose connects to the fuel tank near Box 5 and runs into PVC pipe covered by foam (underneath the dotted line) and then inside the white PVC pipe (indicated by Box 6) to the stern.

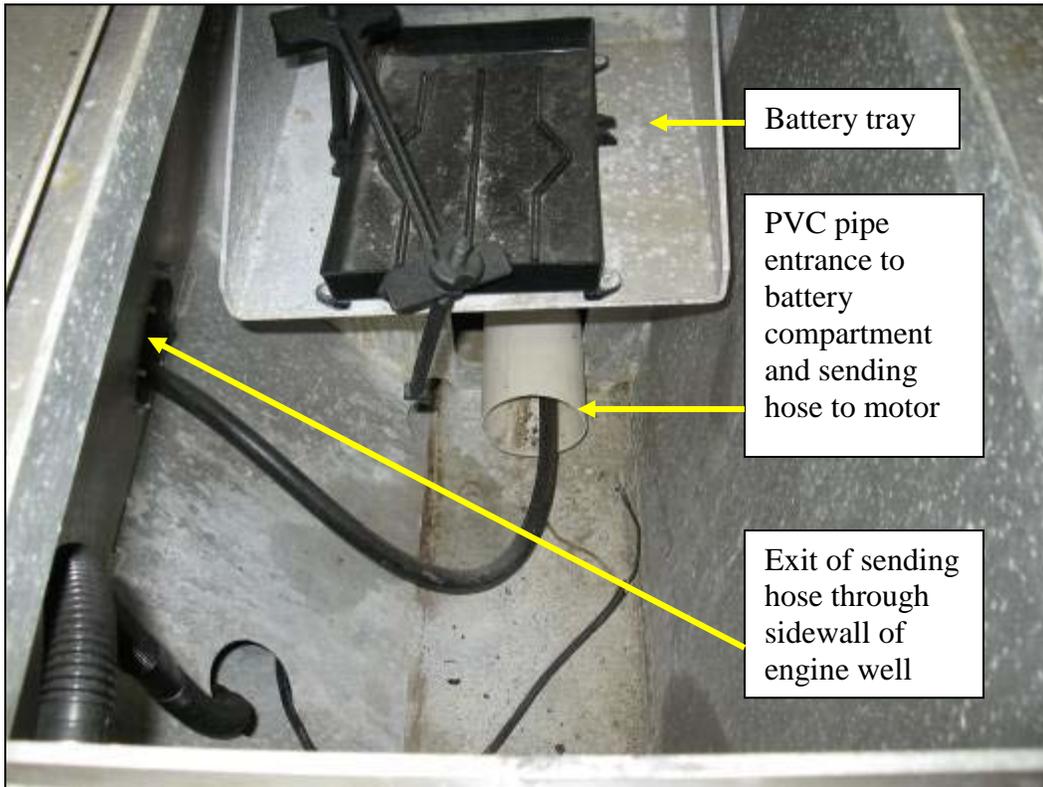
**Figure 6:** Photograph of an identical but undamaged vessel, showing the entrance of the PVC pipe (which contains the sending hose) to the battery compartment at the stern.

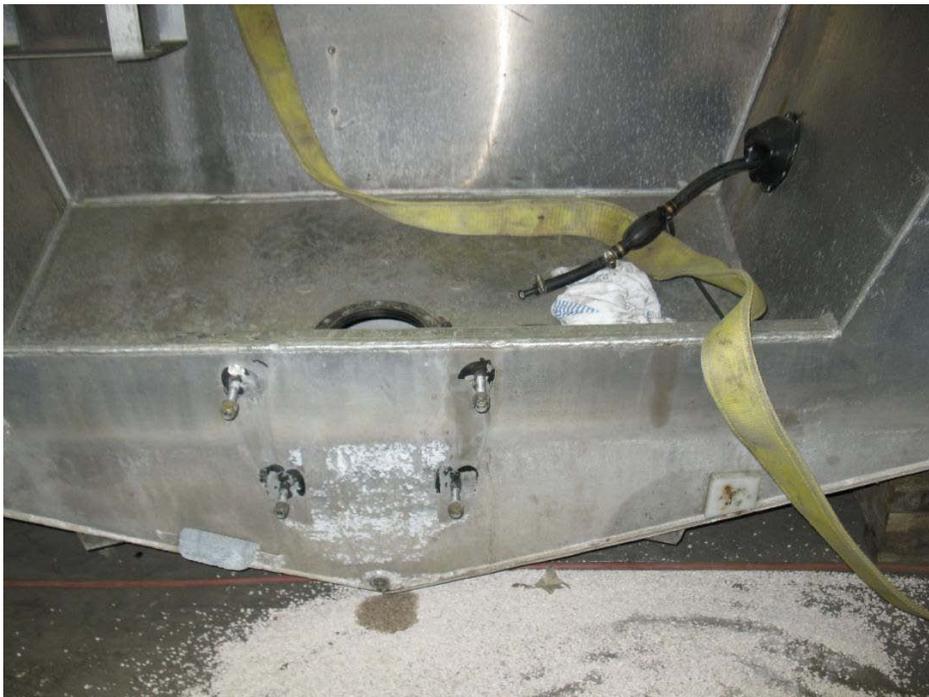
**Figure 7:** This photograph of an identical but undamaged vessel shows the sending line (black hose with a fuel priming bulb) entering the engine well through the hole from the battery compartment.

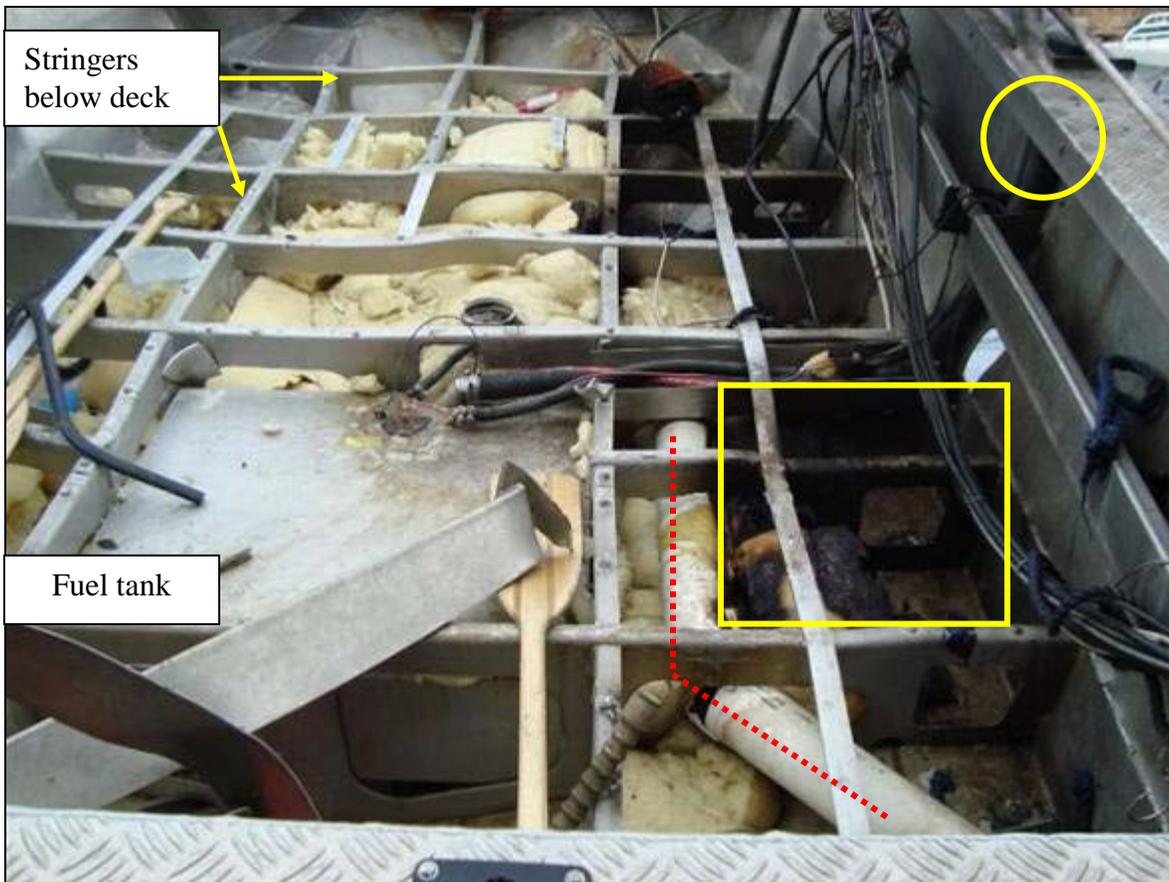
After the incident, the hose clamp that attached the filler line to the fuel intake below the starboard gunwale was loose enough to be easily hand-turned (see Figure 8). It is impossible to determine whether the clamp was already loose before the explosion or whether the force of the explosion loosened it. The fact that all the other fuel hose connections at the tank remained tightly secured after the explosion suggests that this particular clamp may already have been loose before the explosion, allowing gasoline to leak out of the filler line.

**Figure 8:** Interior of the damaged boat. The circle indicates the location under the starboard gunwale where a hose clamp on the filler line was loose. The area that was most burned was to the right of the fuel tank (enclosed by the square). The dotted line indicates portions of the white PCV pipe that contain the sending hose.

It is notable that the most charred portion of flotation foam was immediately adjacent to the area below the filler line (shown in Figure 8). It is very likely that gasoline leaking from the loose filler line dripped into this section of flotation foam. The foam burned more on the bottom surface than on the top surface, suggesting that gasoline pooled in the hull and saturated the bottom portion of the foam (see Figure 9). This may have been partly why it proved difficult to put out the fire by spraying water onto the top of the foam: most of the fuel was underneath the foam and absorbed by the foam.

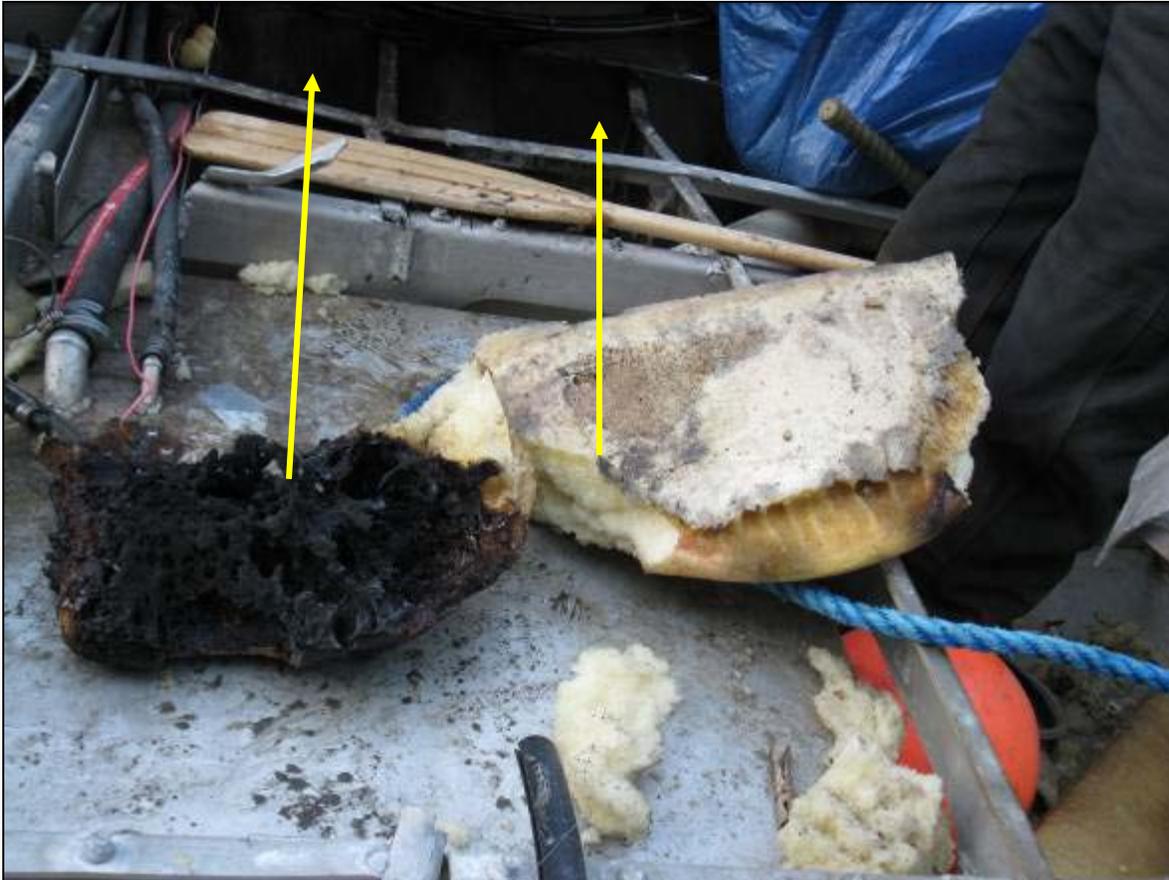
**Figure 9:** Flotation foam removed from the hull of the boat. The arrows point to where the investigator removed the pieces of foam. The bottom surface of the charred foam was more burned where it had contacted the surface of the hull.

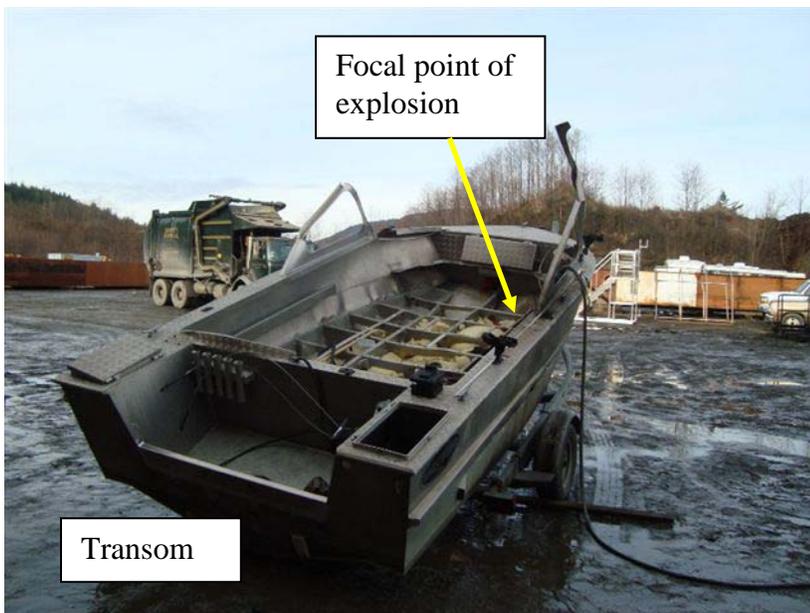
**Figure 10:** The damaged boat was moved outside after the incident. The explosion occurred while the boat was inside the shop.
