# What's wrong with this photo?

# Improper ladder use a frequent source of injury

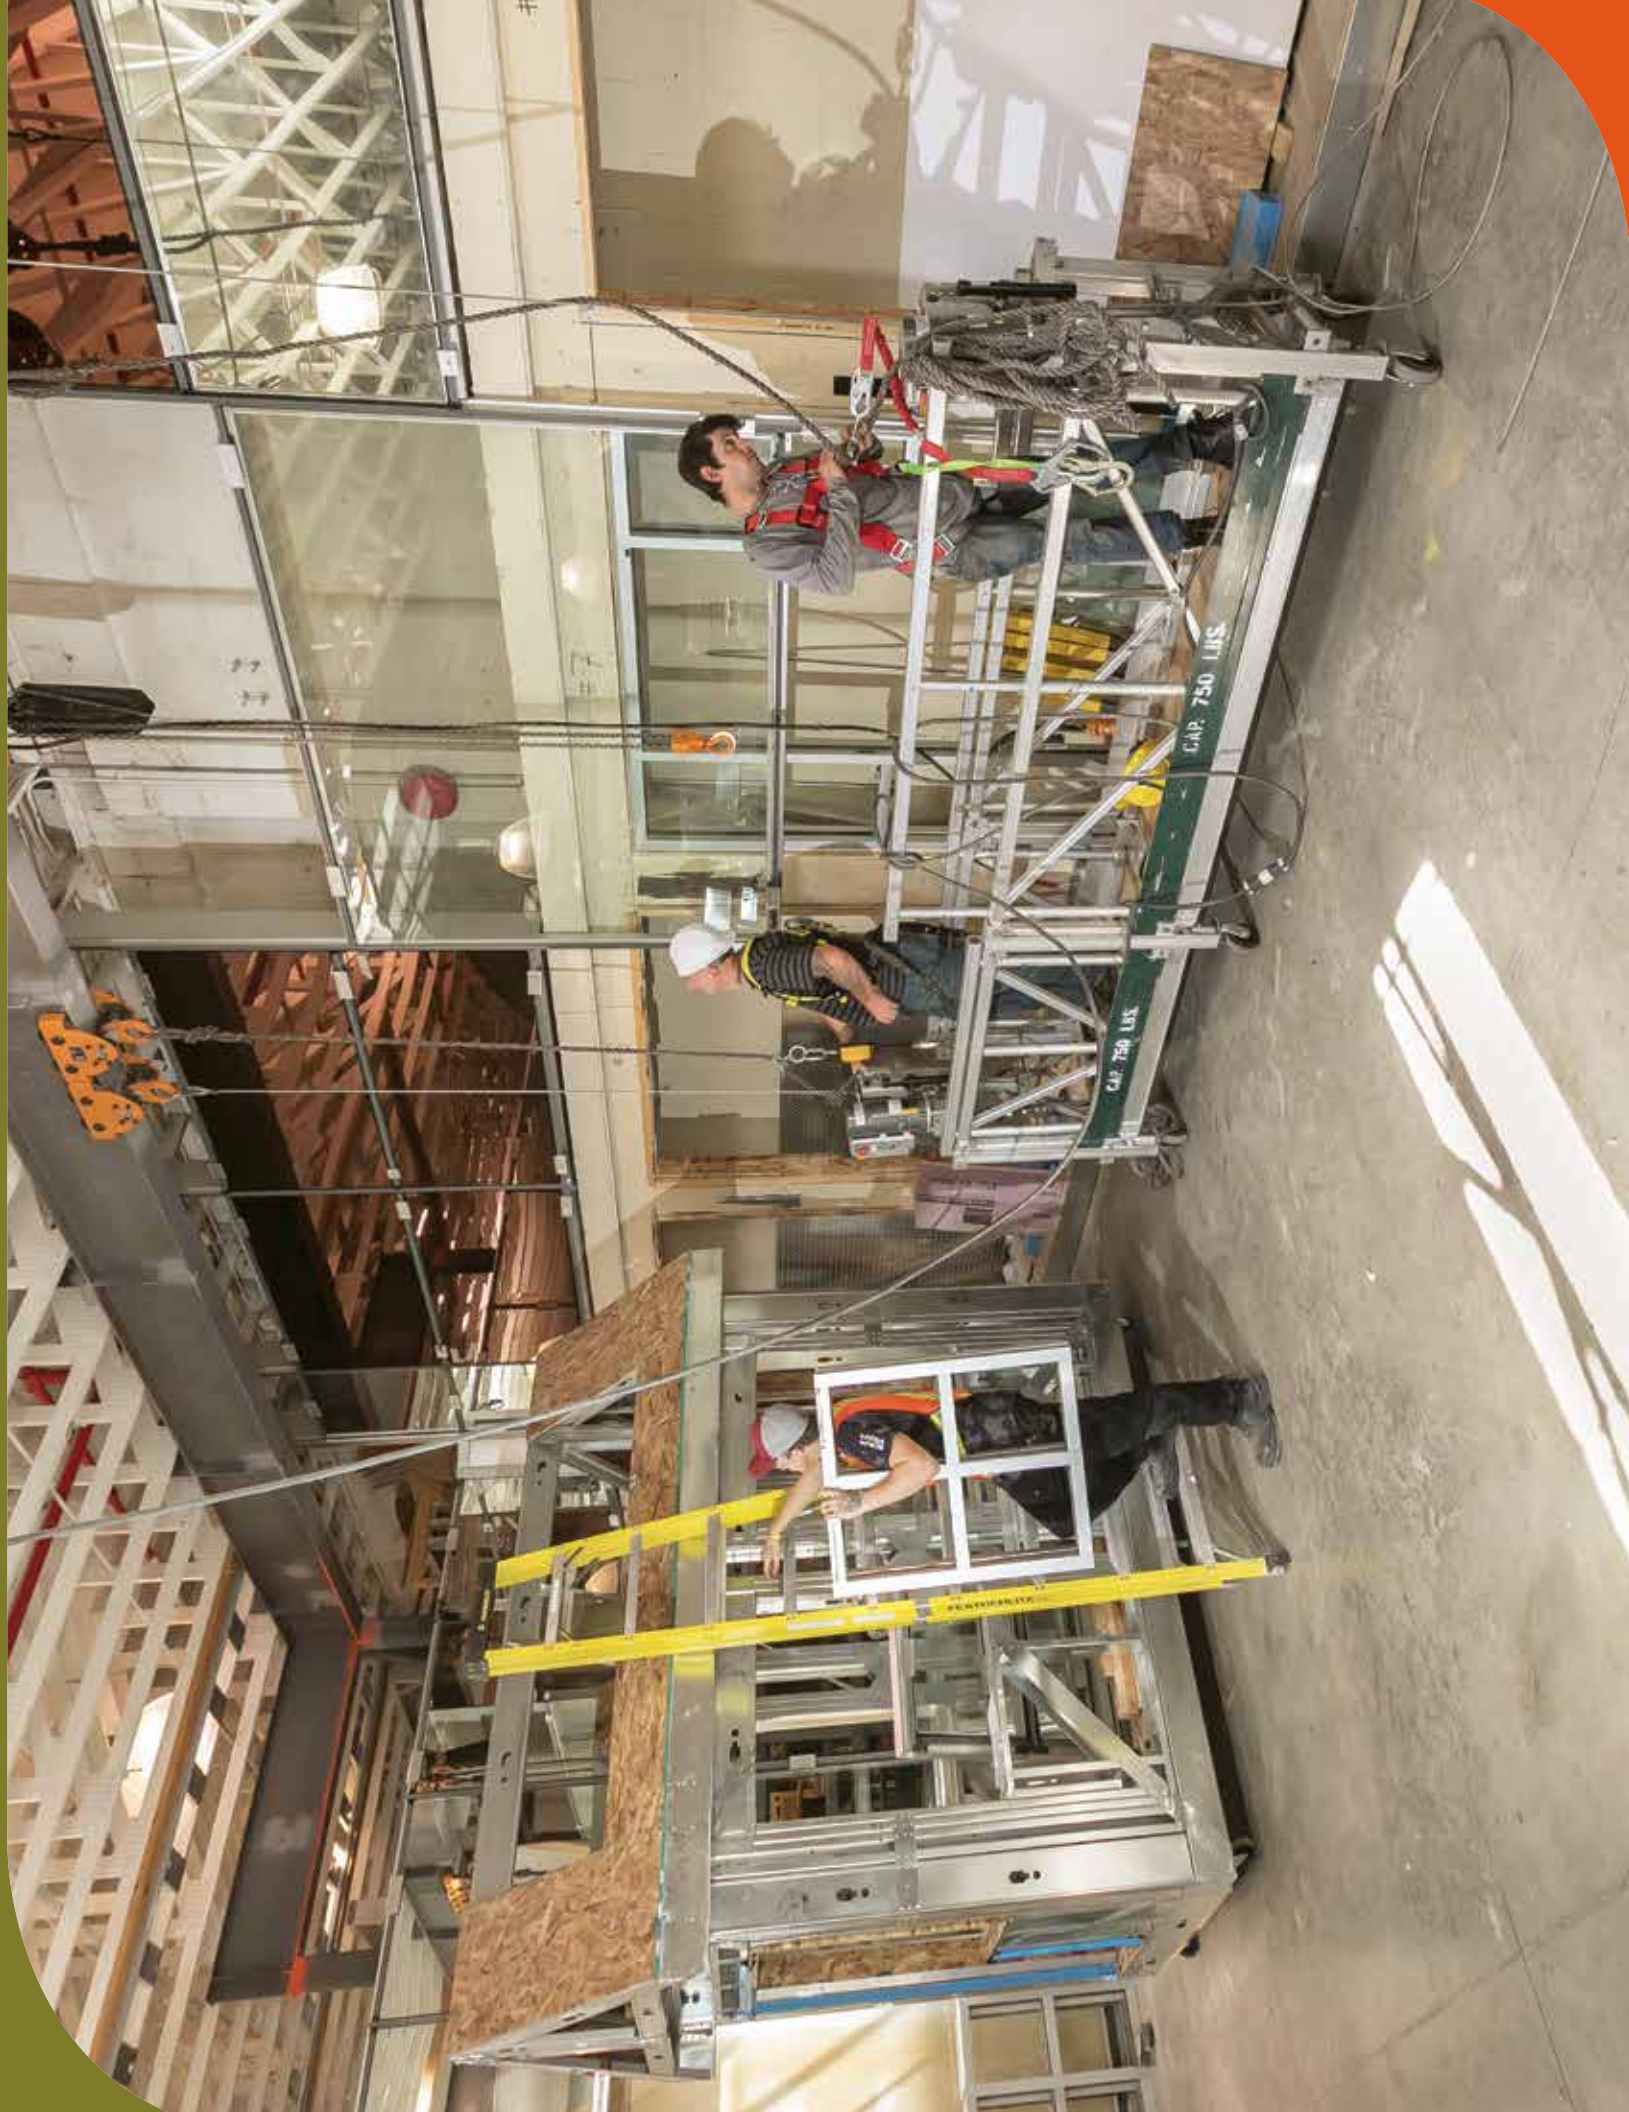
The photo above has been deliberately staged to display dangerous work habits. We're inviting you — as dedicated employers, employees, and health and safety professionals — to tell us how many hazards you spot. Email your responses to [wwtp@worksafebc.com](mailto:wwtp@worksafebc.com) by October 12, 2018. And, if you'd like to try the online version, go to [worksafemagazine.com](http://worksafemagazine.com), and click on "What's wrong with this photo." Please include your full name, work title, workplace, and workplace location.

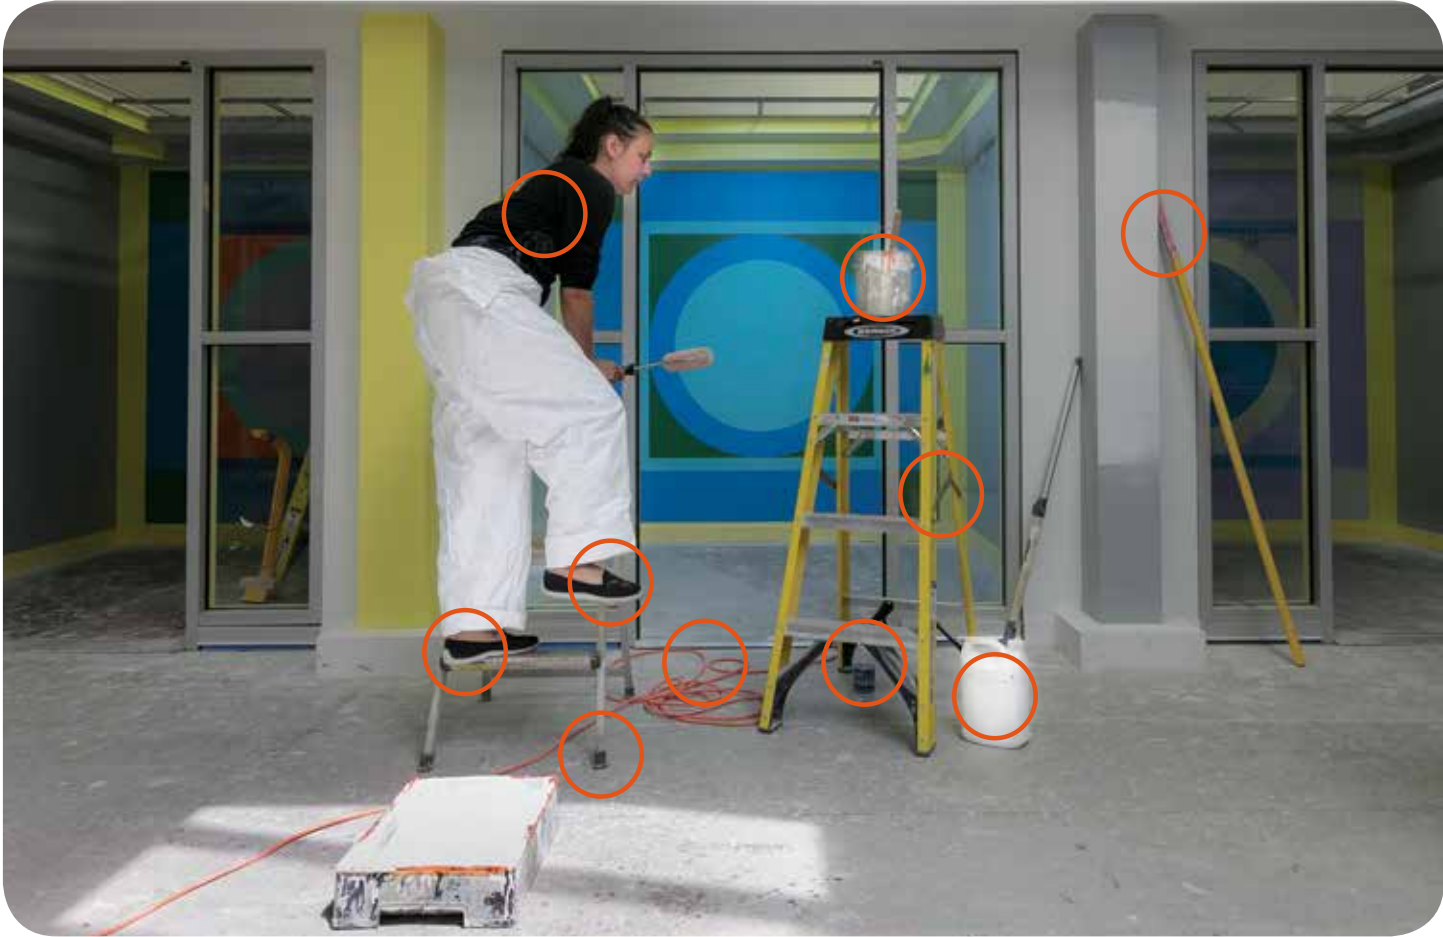
WorksafeBC occupational hygiene officer Kimiko Banati helped set up this photo of unsafe ladder use. Here's what was wrong:

- The worker is not wearing safety boots.
- The worker is using a light duty ladder on a construction site.
- The Tyvek suit is only on the bottom part of the worker's body. It is not being worn properly.
- The worker appears to be stepping towards the second ladder without coming off of the first one.

- The reach pole would be more appropriate for reaching high up spots than the step ladder.

- There are unlabeled solvent and paint containers.
- The paint tray is positioned directly behind the ladder. This is a trip hazard.
- There is a paint can sitting on top of the ladder instead of on a pail shelf.
- There are electrical cords under and behind the ladder.
- The yellow ladder does not have the spreader locked in.
- There is a beverage container in the work area.
