Worker pulled into rollers of potato harvester

Purpose of this report

Number: 2011144570134

Date of incident: August 2011

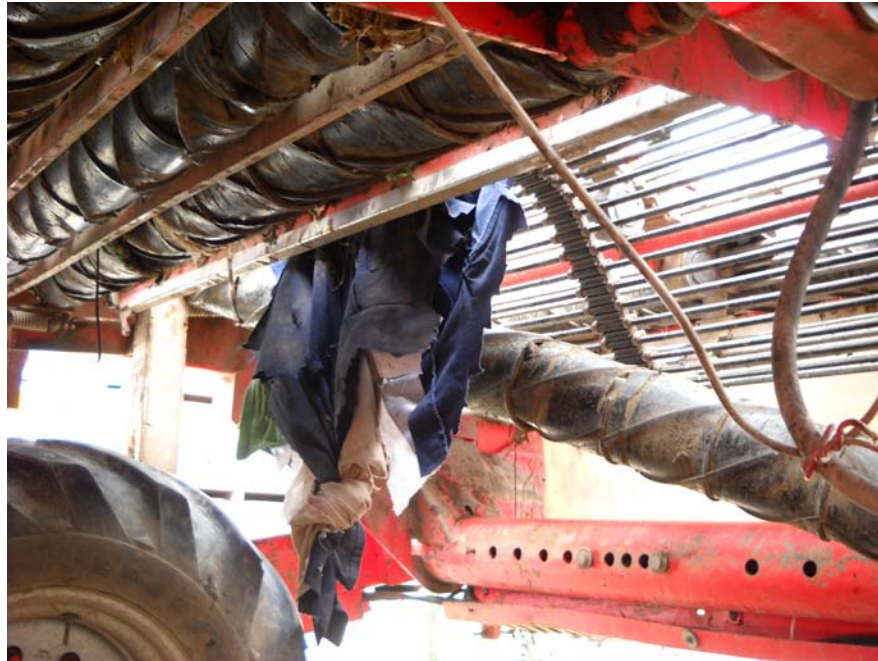
Two workers were assigned mechanical maintenance tasks on a large, mechanized potato harvester. While the machine was energized, one of the workers became trapped in a component of the equipment that was not guarded. The worker was trapped for more than one hour and sustained serious injuries as a result of the incident.

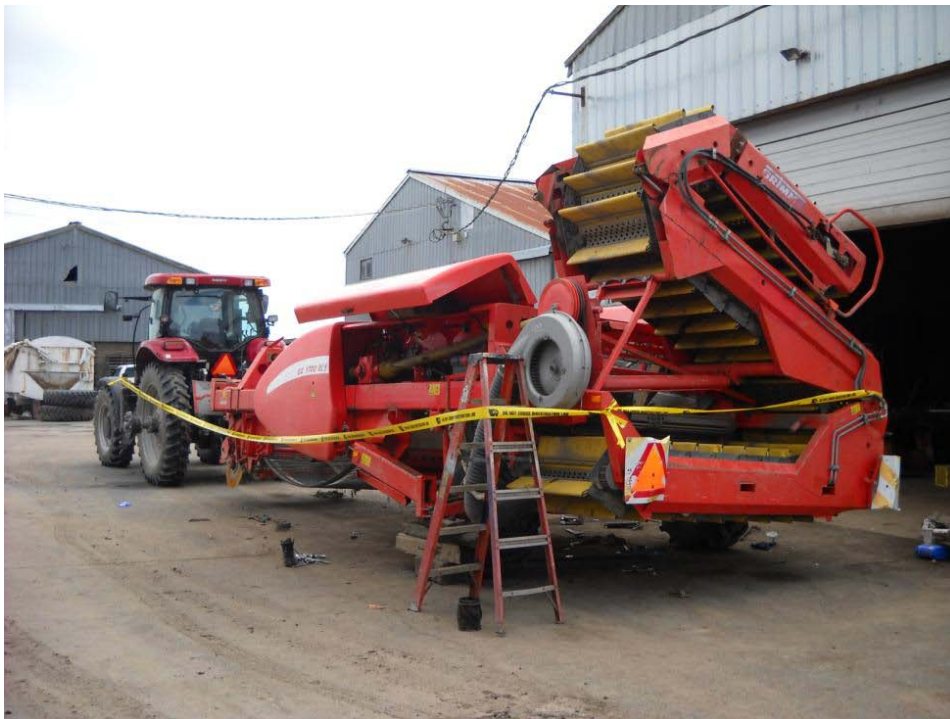
Figure 1: The six-foot stepladder gives a sense of the size of the potato harvester. (This photograph, taken after the incident, does not show the area where the incident occurred.)

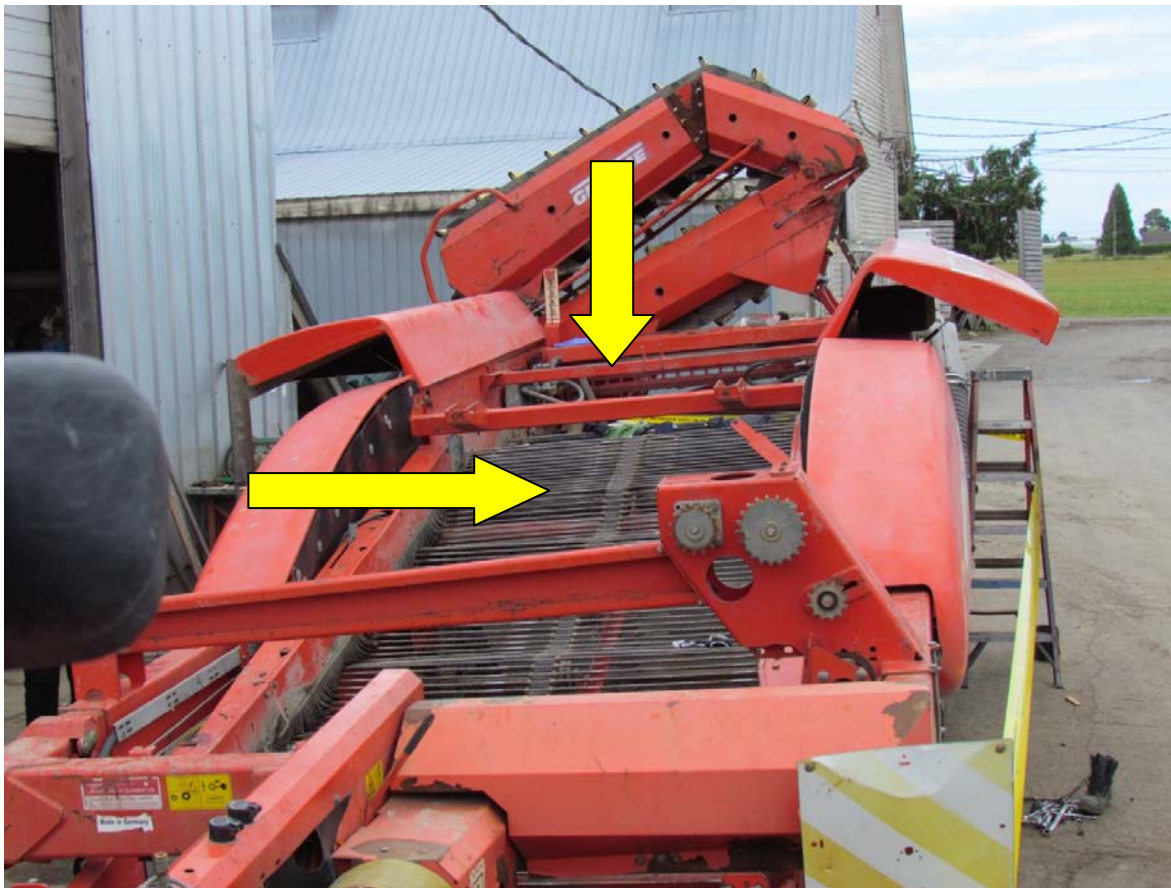
The workers changed the parts on the left side of the harvester. Worker 2 got into the cab of the tractor and turned the key that had been left in the ignition. This powered up the harvester through the power take-off. Worker 2 also activated the hydraulics powering the haulm rollers. While the machine was running, Worker 2 then went under the web conveyor (see Figure 2) to see if the rollers were turning.

Figure 2: Front view of the potato harvester. The top arrow shows where the haulm rollers are located and the general location where Worker 1 became trapped. The lower arrow shows the web conveyor, which carries the potatoes and other materials along to the haulm rollers for separation.

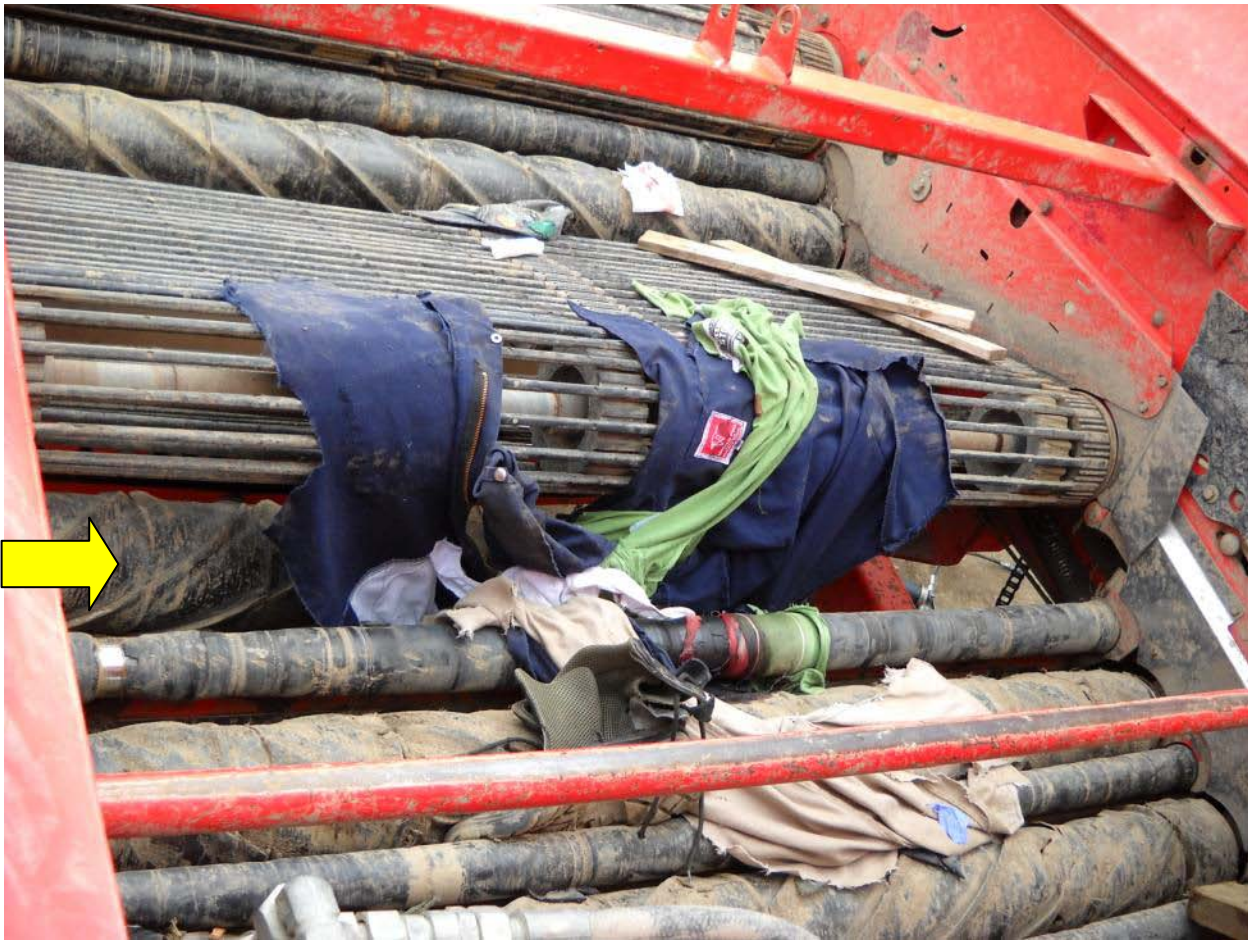
While Worker 2 was under the harvester, Worker 1 climbed on top of the machine to visually check the rollers. There were no safeguards over the rollers. When he got to the top of the harvester, he slipped and was pulled into the machine by the haulm rollers. Worker 1's leg was pulled into the machine up to his hip. The boot of his other foot was also trapped in the rollers. Figure 3 shows where Worker 1 was trapped.

Figure 3: A view of where Worker 1 was trapped in the haulm rollers. The arrow identifies one of the haulm rollers.

The missing safeguards were a cause in this incident. Worker 1 was pulled into an area of the harvester that should have been guarded. This resulted in Worker 1 becoming trapped and sustaining serious injuries.

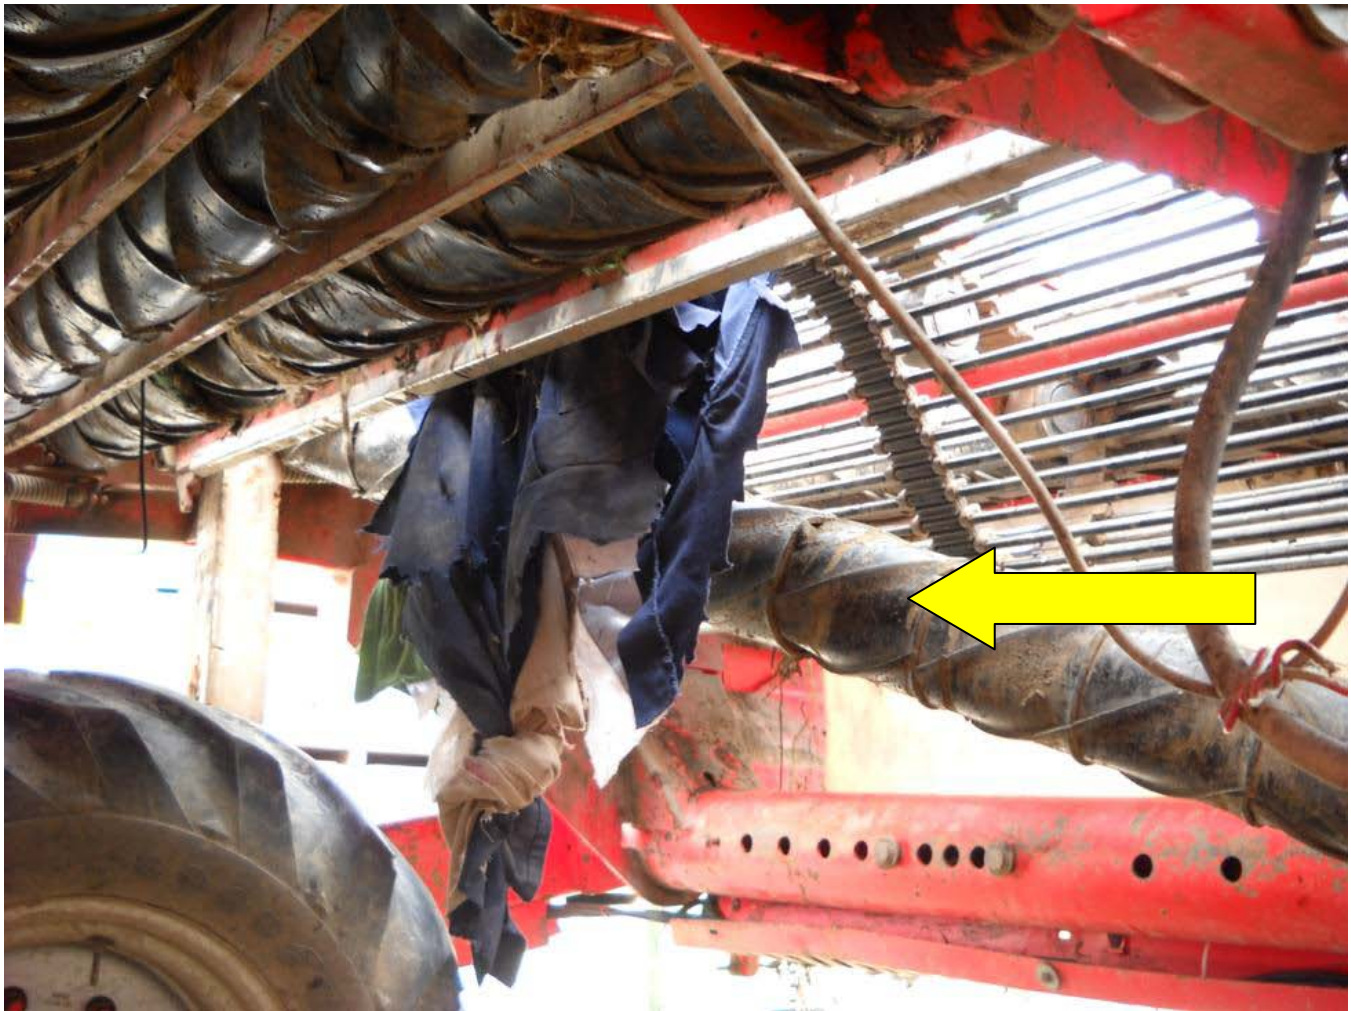
Rescue workers took more than an hour to complete the extrication. They were unable to use their cutting tools because the tools regularly carried by fire and rescue services could not cut through the hardened steel of the harvester. Instead, they had to partially dismantle the machine to free Worker 1 (see Figure 4).

Figure 4: The arrow shows the haulm roller that pulled Worker 1's leg into the harvester and trapped it. Emergency responders had to drop the roller from its original position to extricate the worker.

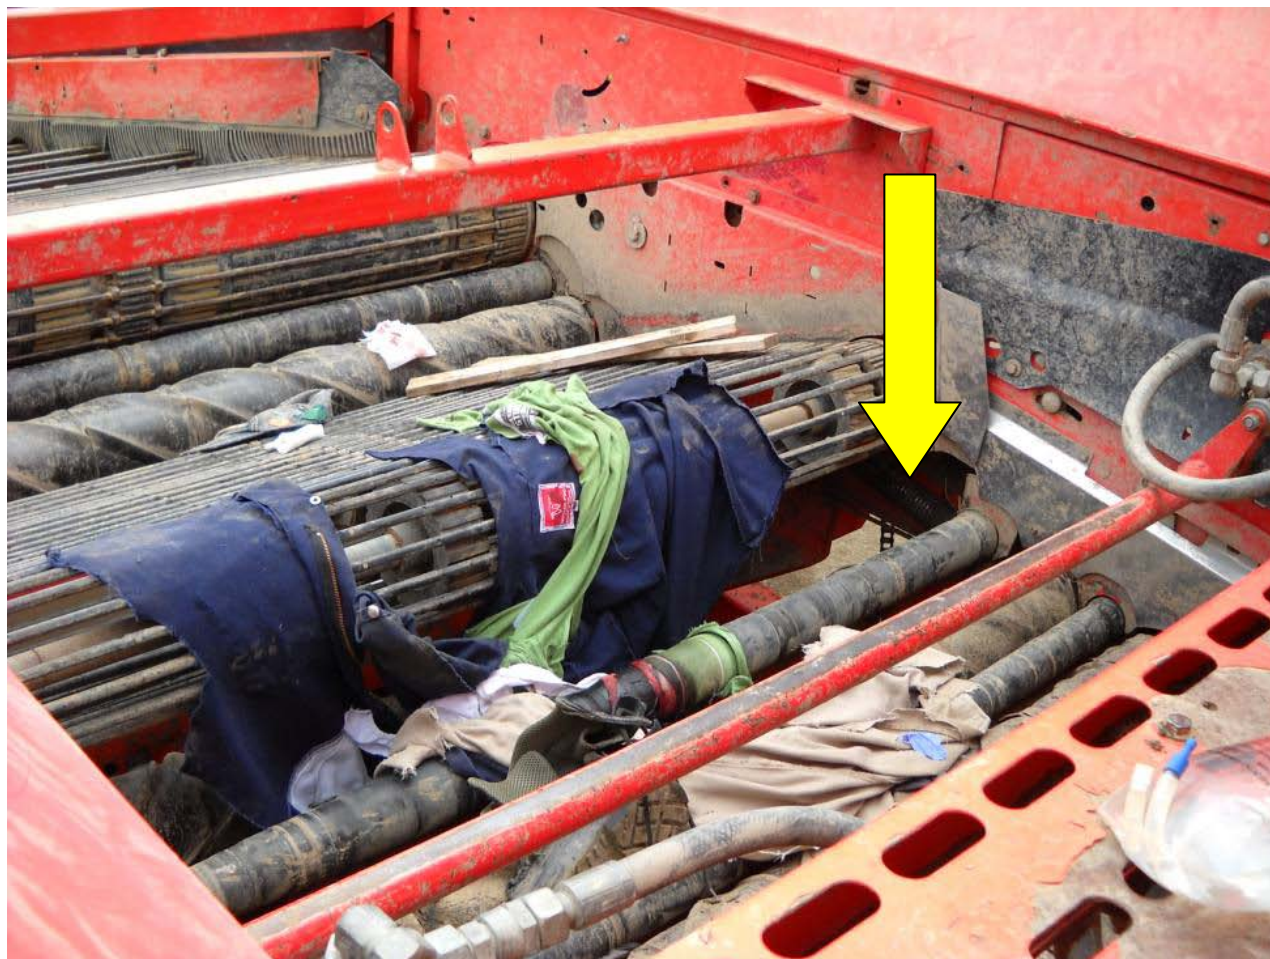
This model of potato harvester is equipped with safeguards over the haulm rollers that are designed to prevent workers from being caught in the moving parts (see Figures 5 and 6). The safeguards are hinged and fixed in place with a spring-loaded locking system that requires a tool, such as a screwdriver, for removal. The manufacturer’s manual states: “Only start the machine up if all protective guards are fitted and in their protective positions!”

Figure 5: The arrow shows where Worker 1 was trapped in the unguarded haulm rollers.

This potato harvester is designed to be operated only if the safeguards are fitted over the haulm rollers. Although the employer had the safeguards on site for at least two years, they had not been installed over the rollers at the time of the incident. No explanation for their absence was given. The other harvesters owned by the employer did have the safeguards installed over the rollers.

The employer was ordered to ensure safeguards are fitted as required by [section 12.2\(b\)](#), which states that unless elsewhere provided for in the Occupational Health and Safety Regulation, the employer must ensure that machinery and equipment is fitted with adequate safeguards which ensure that a worker cannot access a hazardous point of operation.

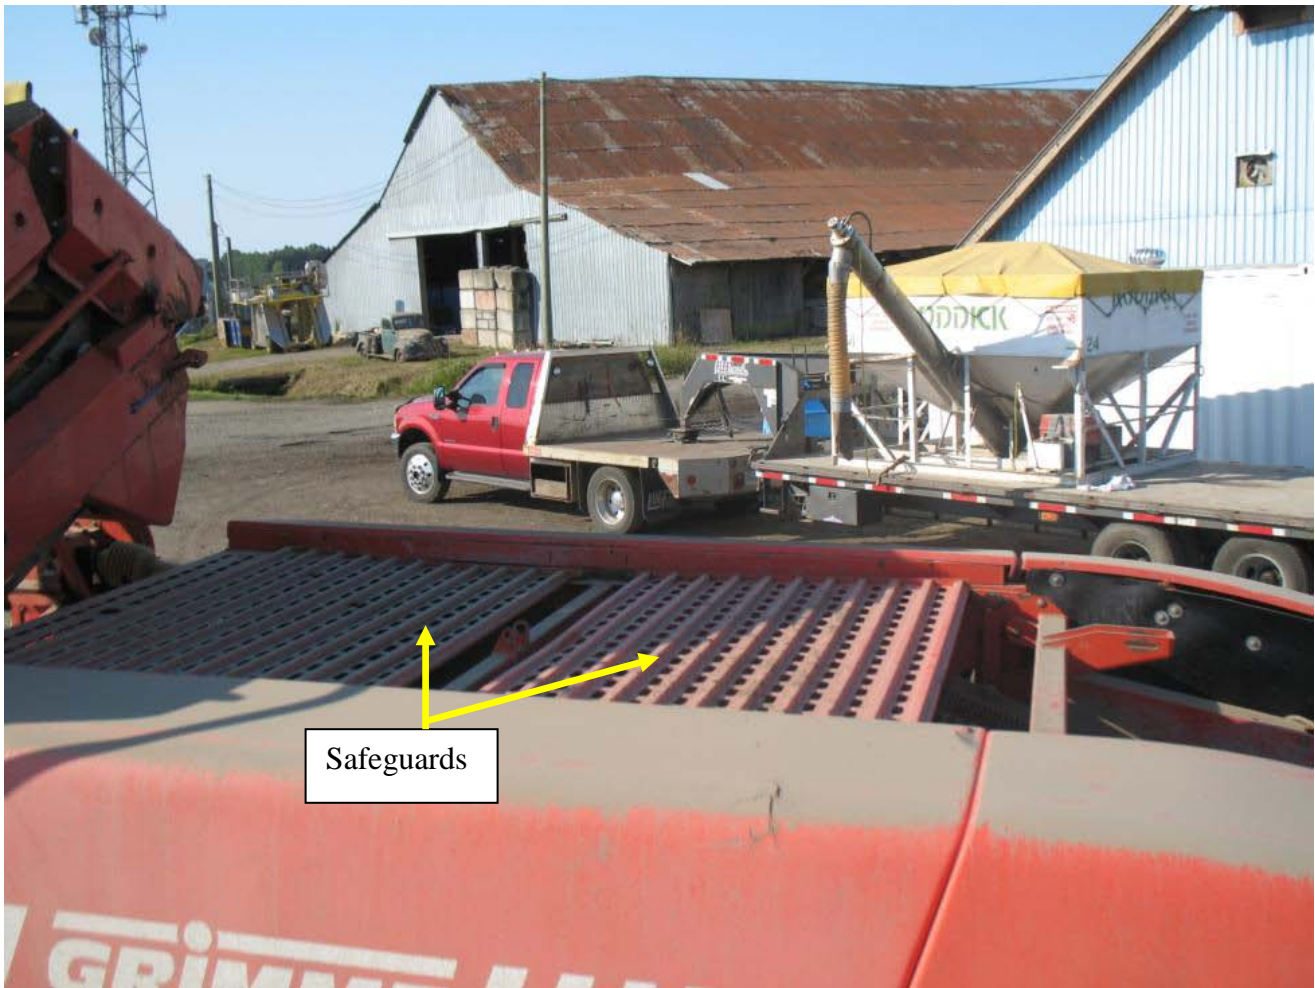
The farm has three potato harvesters, two of which had safeguards over the haulm rollers. Although the employer had the safeguards for the harvester involved in the incident, they had never been installed on the machine. The guards had been stored on the farm for at least two years before the incident.

Figure 6: This photograph shows the safeguards that should have been installed over the haulm rollers. The safeguards are designed to keep workers from being pulled into the machine.
