# WorkSafe

Tools for building safer workplaces | worksafemagazine.com | May / June 2021

# The evolution of electric vehicle safety

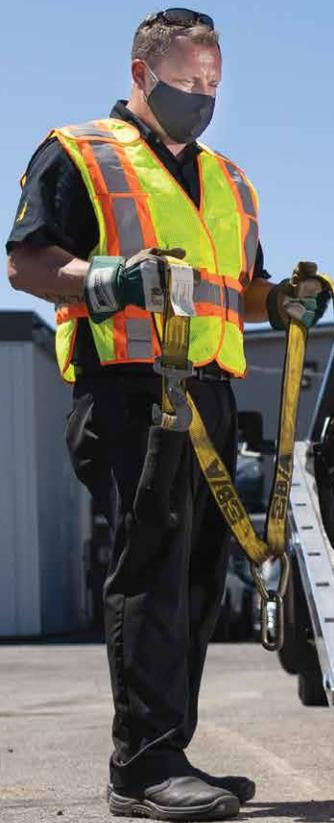
**On the front cover:** Neon skates are recommended by the electric vehicle manufacturer, Tesla, to help aid loading and unloading. Skates can be used if a vehicle is stuck in parking mode or the parking brake won't release. They reduce drag friction by 66 percent, allowing the operator to stay within working load limits while using the wire rope (winch).

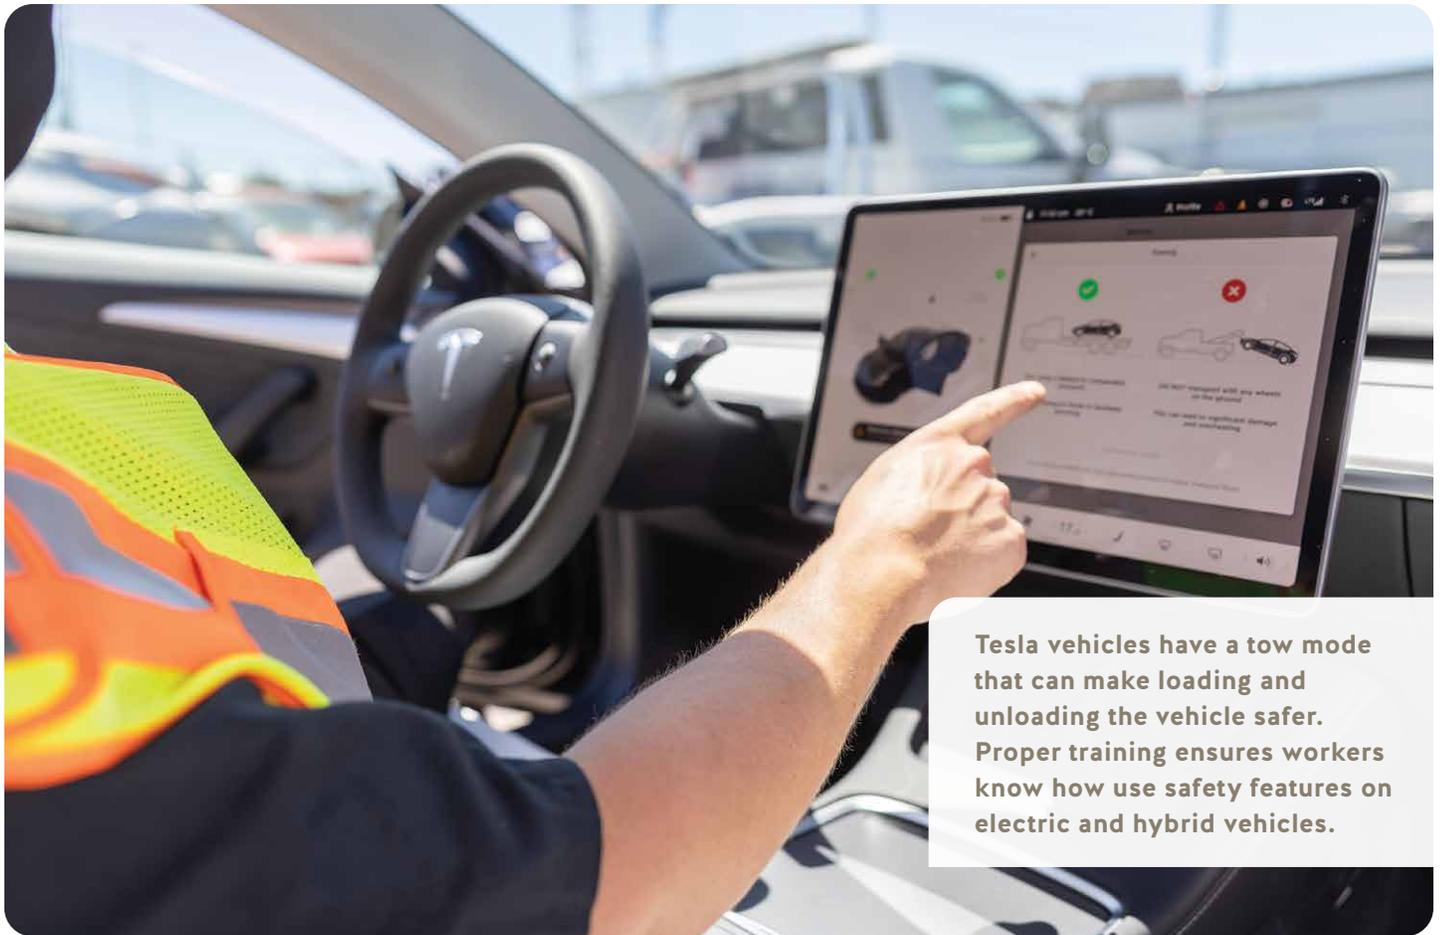
**Tesla vehicles have a tow mode that can make loading and unloading the vehicle safer. Proper training ensures workers know how use safety features on electric and hybrid vehicles.**

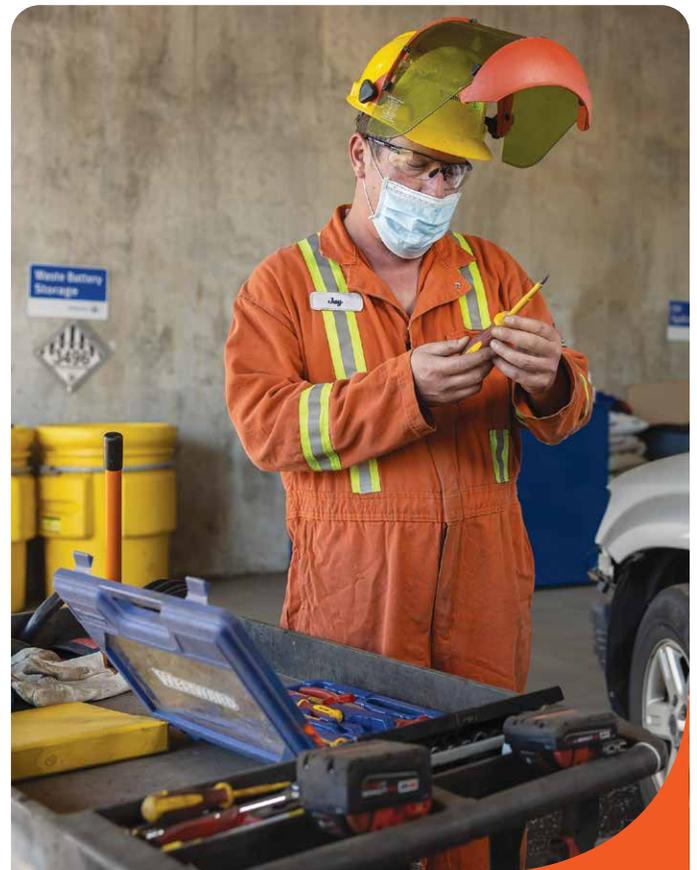
**A worker visually inspects insulated tools before processing a hybrid vehicle for recycling.**

Only senior dismantlers handle EVs after undergoing training on proper safety protocols, including wearing lineman or highwire gloves to protect against electric shock, along with other personal protective equipment (PPE).
