INCIDENT INVESTIGATION REPORT

Type of occurrence Exposure to/contact w/ hazardous substance/environment		
Notice of incident number 2017160530032	Incident outcome Fatals (3)	Date of incident October 17, 2017
Location of incident Fernie Memorial Arena 991 6th Avenue Fernie, B.C.	Lead investigator Nigel CORDUFF	Investigation file number FSI-REG-2017-0123
Approved by manager, Fatal and Serious Injury Investigations Jeff YOUNG	Signature 	Date Aug. 22 / 2018

This incident investigation report sets out WorkSafeBC's findings with respect to the cause of and underlying factors leading to the workplace incident that occurred on October 17, 2017, at the Fernie Memorial Arena in Fernie, British Columbia. The purpose of this report is to help employers and workers understand the factors that contributed to the tragic incident so that similar incidents can be prevented in the future.

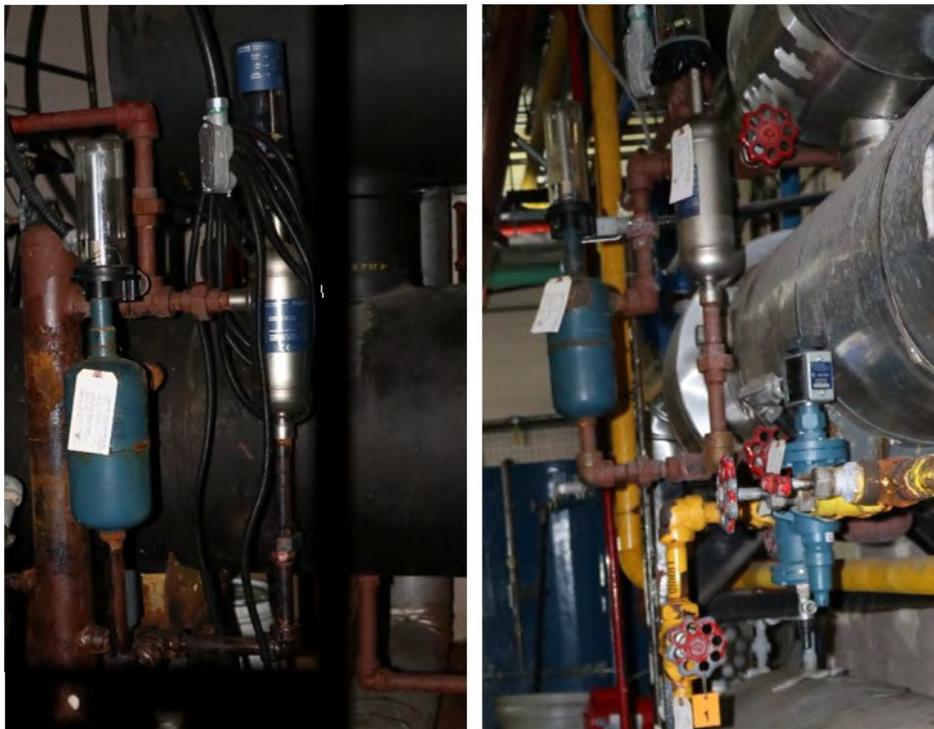
Figure 7: The photograph on the left shows the hockey rink chiller liquid level control (blue tank) and the ammonia liquid high-level shutdown switch (silver tank). The photograph on the right shows the same control and switch on the curling rink chiller.

As outlined in section 2.2.4 above, WorkSafeBC investigators did not find any evidence that the gas compressors had been damaged from ingesting ammonia liquid. As such, the intentionally disabled ammonia liquid high-level shutdown switches were not a direct contributing factor in the incident. The evidence shows the refrigeration equipment had been operated and maintained previously while system components were known to be in a disabled or otherwise substandard mechanical condition.

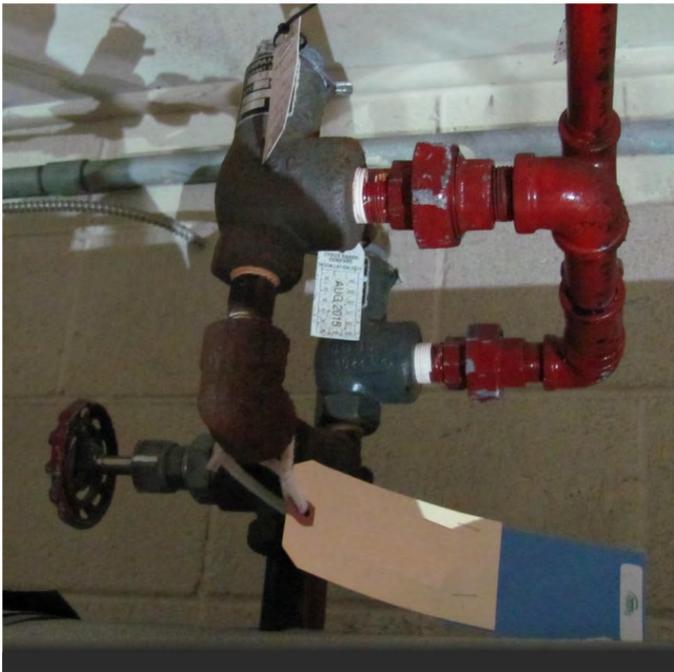
The curling rink chiller was fitted with two pressure-relief valves connected to a dual-port manifold (see Figure 17). The manifold was designed so that if flow to one valve was cut off, flow was always provided to the second valve. It was not possible to isolate both valves from flow at the same time. Although the two valves were manufactured at different times, they were both supplied by the same manufacturer and were installed on the same date in August 2015. The pressure-relief valve in service at the time of the incident was examined at the laboratory using high-powered digital microscopes in the presence of manufacturer representatives. There is no evidence to indicate that the pressure-relief valve had opened during the incident. The second pressure-relief valve was tested and found to be operating as intended. The factory-set opening pressure for each valve was 150 psi.

Figure 17: The pressure-relief manifold installed on top of the surge tank for the curling rink chiller.

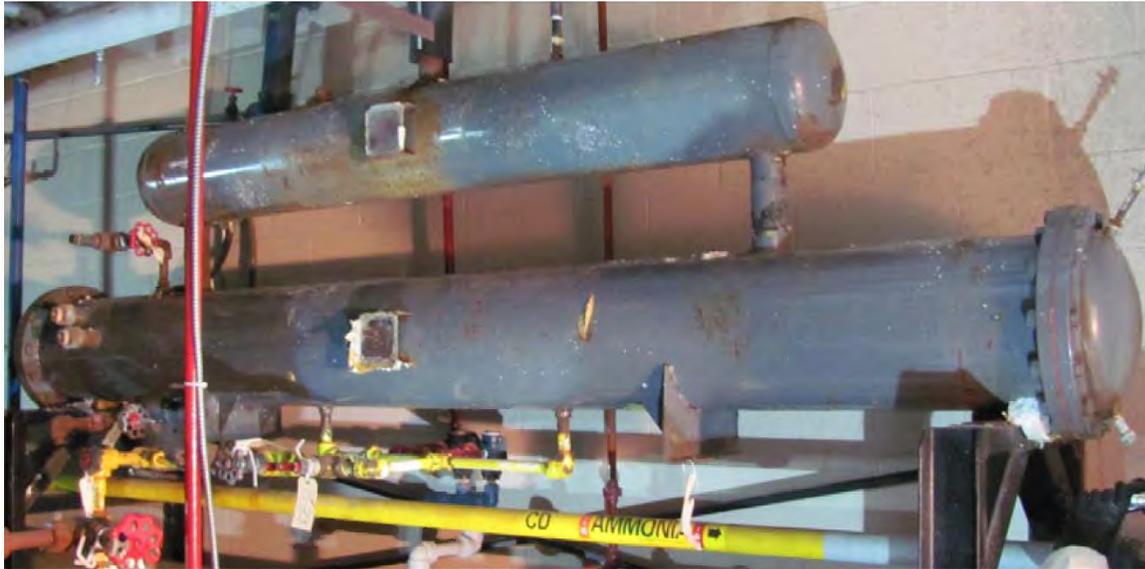
The curling rink chiller was examined in place. The insulated cladding was removed, and the exterior of the chiller showed minimal corrosion on the outside of the ammonia pressure shell. (See Figure 18.) The two dome-shaped end plates (heads) were removed in place. After the heads were removed, all of the gaskets were observed to be intact and in serviceable condition for their intended use.

Figure 18: The curling rink chiller with the insulated cladding removed.
