# HAZARD ALERT

## Abrasive wheel on grinder breaks, killing worker

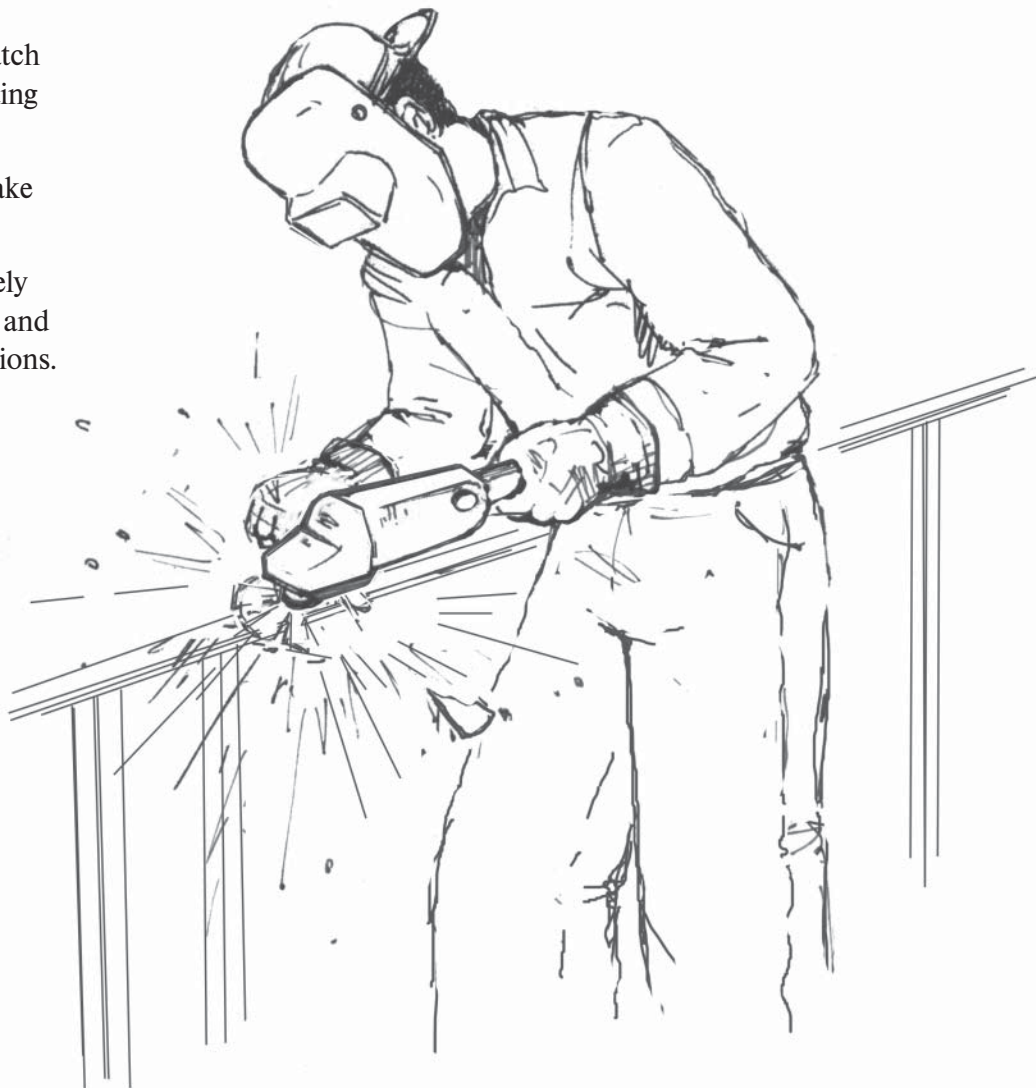
A worker was using a hand-held 5-inch angle grinder while working on a wrought iron gate when the abrasive wheel broke and pieces flew off. One piece cut into the worker's thigh, severing a large artery. The worker collapsed from the blood loss and later died.

The accident investigation found that the abrasive wheel that broke was rated for a maximum of 6,110 rpm but the angle grinder was rated at 10,000 rpm. As well, the abrasive wheel was larger than 5 inches in diameter, preventing the installation of the guard provided with the grinder.

- Use only abrasive wheels that match the diameter and speed (rpm) rating of the grinder.
- Before using a grinder, always make sure the guard is installed.
- Ensure that workers are adequately trained in the safe use of grinders and that they know about rpm limitations.
- Always wear adequate eye and face protection when using a grinder. Hearing protection and flame-resistant clothing must also be worn.
