# WORKER FATALITY

### Operator crushed by scissor lift

**Incident Bulletin  
2004 NOA 174**

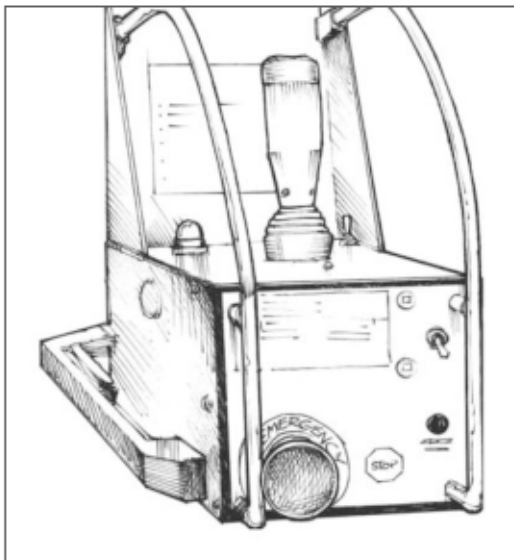
A worker on a self-propelled scissor lift was installing bolts to connect two large overhead steel beams. The platform controls were not protected against inadvertent operation.

The worker inadvertently activated the lever for controlling elevation.

The platform elevated. The worker was pushed firmly onto the control lever when he was caught between an overhead beam and the elevating platform's guard rail.

The platform continued to rise, fatally crushing the worker.

- Use only elevating work platforms with controls that are protected against inadvertent operation.
