Asbestos removal

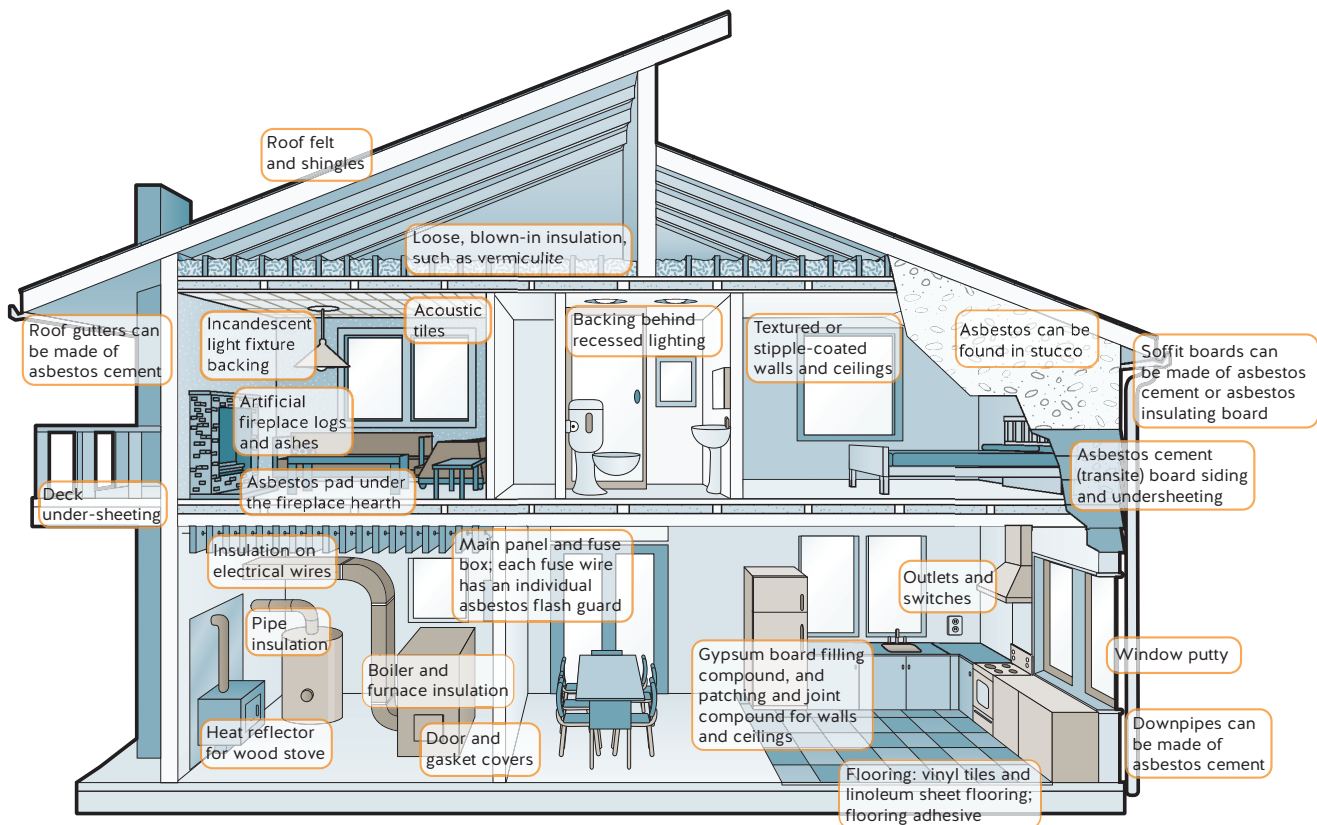
Until the late 1980s, more than 3,000 products containing asbestos were used in house construction. When renovating or demolishing older homes, there is a high probability of encountering asbestos-containing materials. The following illustration shows asbestos-containing materials that were once commonly used in residential construction.
